JOEGREEN ROADMAP TO ENERGY EFFICIENCY™

Audit Date: August 12th, 2010

Building: Steward Elementary School

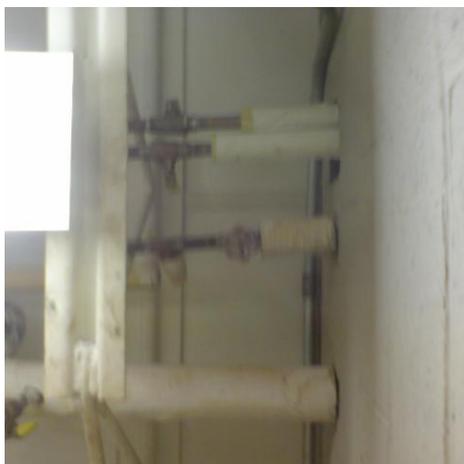
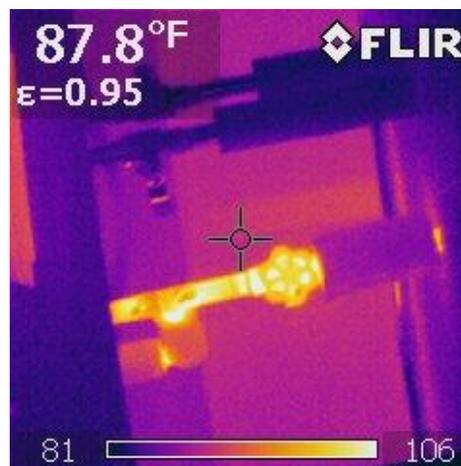
Location: Custodian's Closet across from "Mrs. Mulloy's" Classroom

Observation: These pictures demonstrate the heat loss from even a small area of heated pipe being uninsulated. Several of the pipes in the basement, especially the bonnets and connections, need to be insulated.

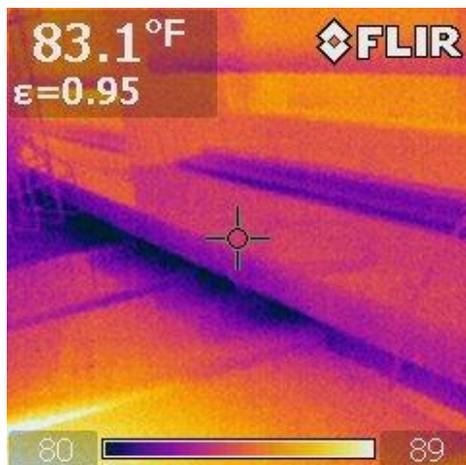
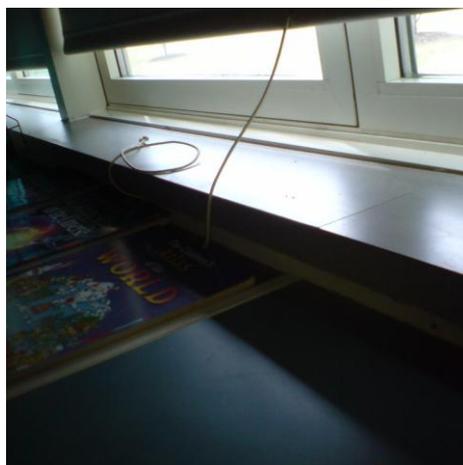
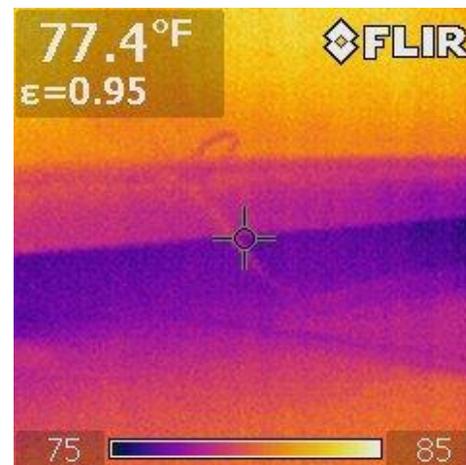
Location: Classroom Windows

Observation: These pictures are an example of the air infiltration from underneath the windows in many of the classrooms. This can be easily remedied by caulking the bottom edge underneath the "lip" formed by the window ledge.

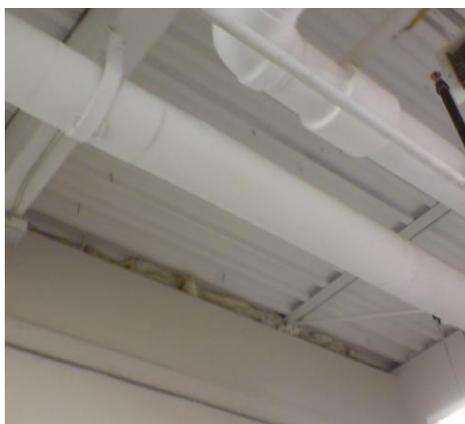
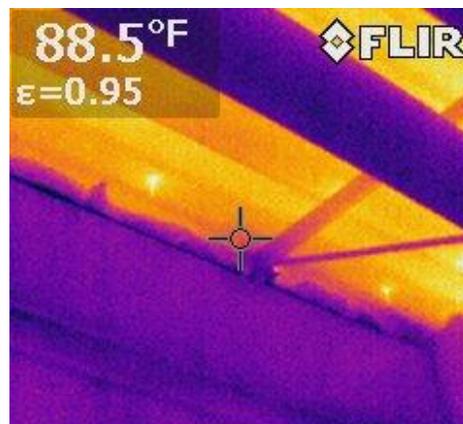
Location: Gym storage area

Observation: The infrared picture demonstrates the heat loss/gain shown by the lack of insulation across the roofline. Note the bags of fiberglass stuffed along the edge. These are not an effective air barrier.

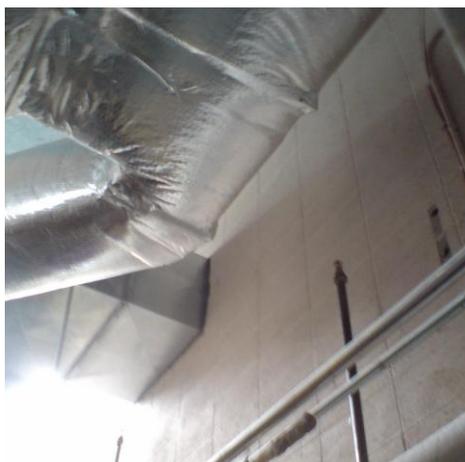
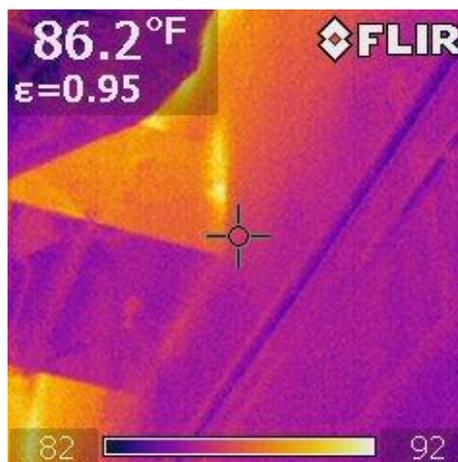
Location: Custodian's Closet

Observation: These air handlers, as well as those found behind the kitchen in the mechanical area, are being exposed to excessive solar heat gain, and are not sealed properly along the edges, as shown in the pictures above.

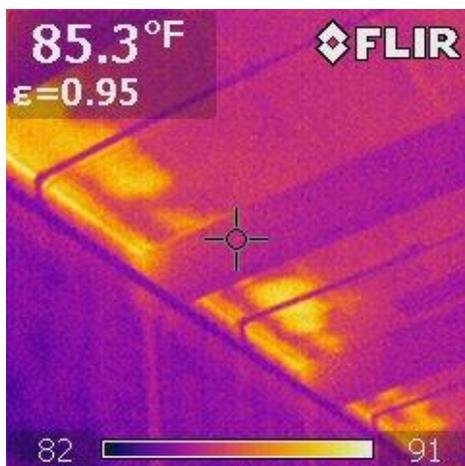
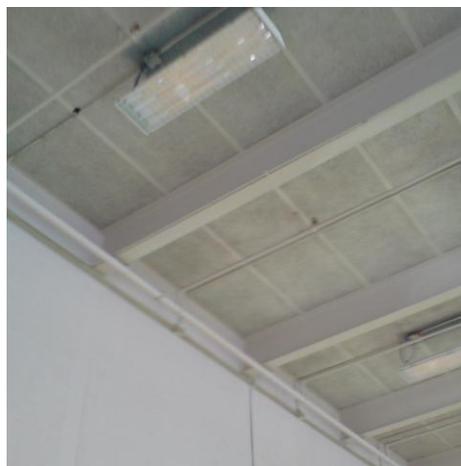
Location: Gym

Observation: An example of the solar heat gain across the roofline of both the cafeteria and the gym. A solar reflector is recommended in these areas.

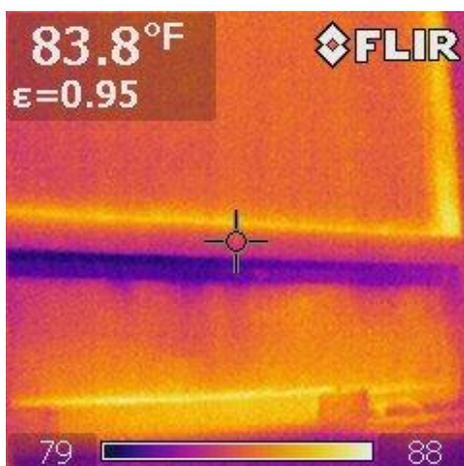
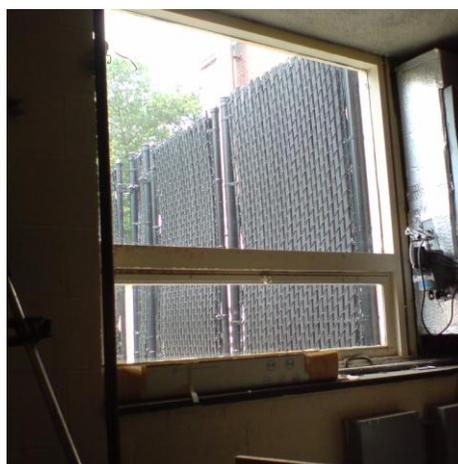
Location: Mechanical room behind the kitchen

Observation: This picture shows the thermal leakage across the single pane windows found in the building, as well as the solar gain to the air handler directly to the right.
