# JOEGREEN ROADMAP TO ENERGY EFFICIENCY™

Audit Date: May 26<sup>th</sup>, 2010

Town of Topsfield Town Hall,

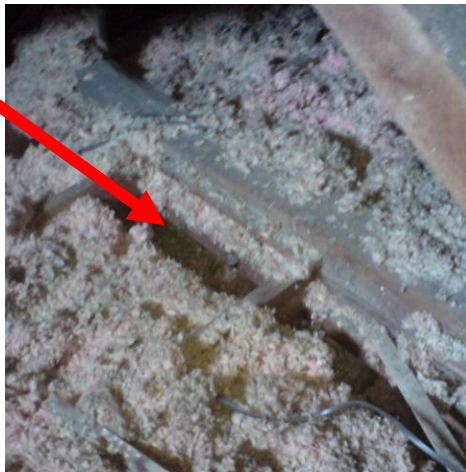
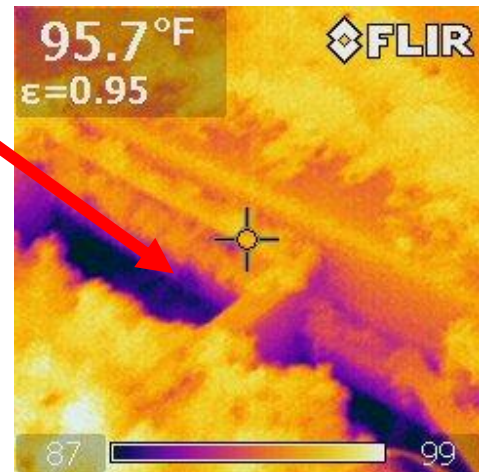
**LOCATION:** Attic

**OBSERVATIONS:** These Gaps in the attic floor allow significant air flow through both the ceiling and walls creating significant energy loss throughout the building.

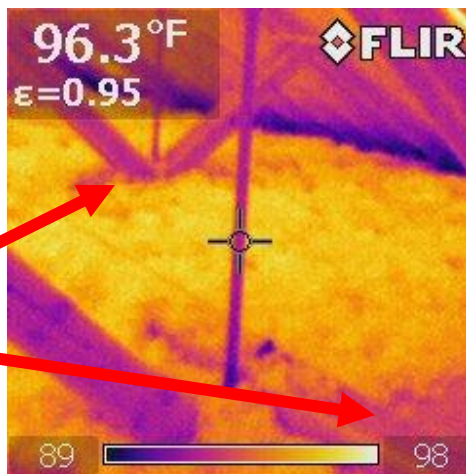
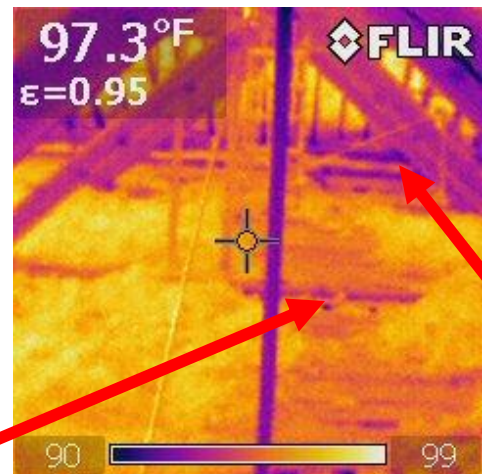
**LOCATION:** Attic

**OBSERVATIONS:** The changes in color across the attic floor represent areas of inadequate insulation which contribute to significant heat loss throughout the building.

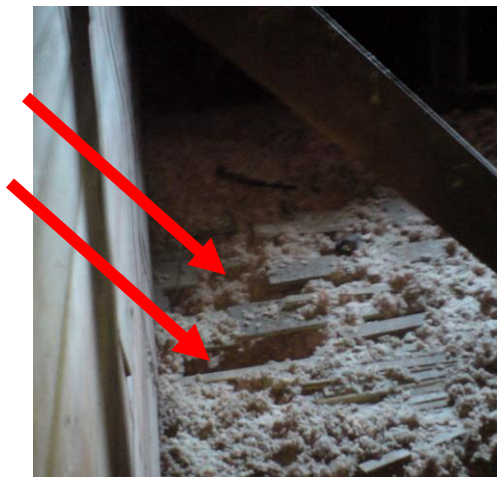
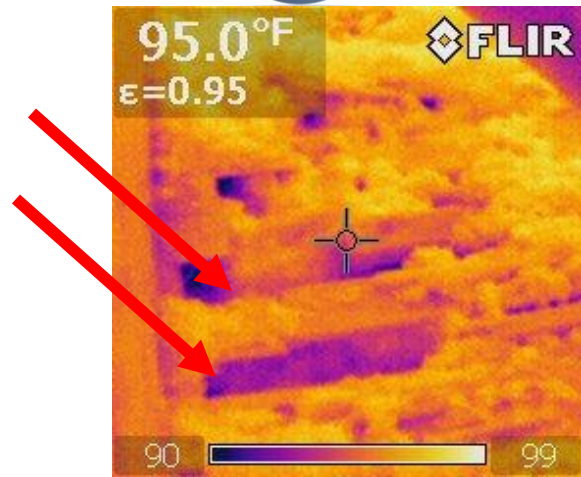
**LOCATION:** Attic

**OBSERVATIONS:** These pictures demonstrate further some of the areas of inadequate insulation in the attic and areas where some of the insulation has been pulled back.

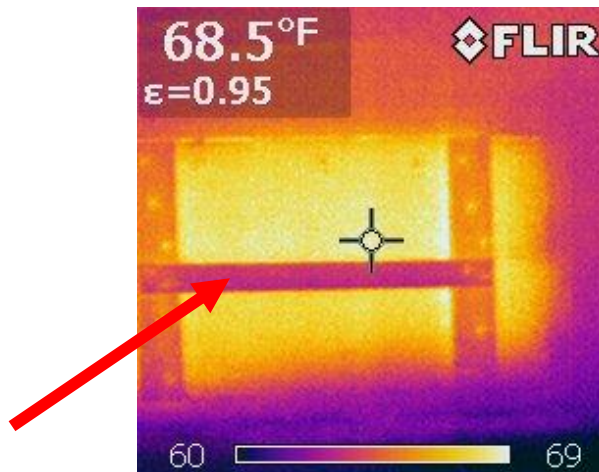
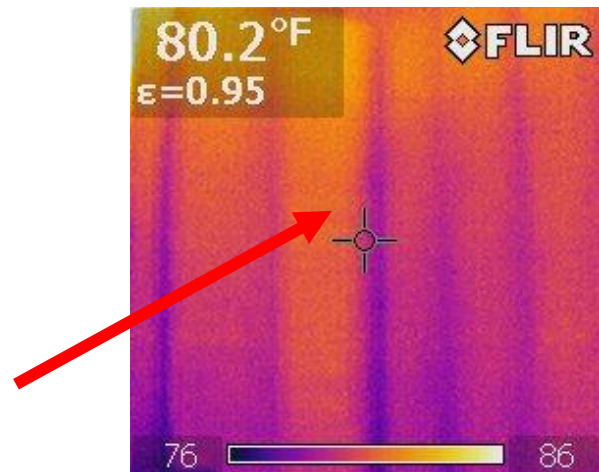
**LOCATION:** 1<sup>ST</sup> Floor West side

**LOCATION:** 2<sup>nd</sup> Floor Break Room

**OBSERVATIONS:** These two pictures demonstrate the lack of insulation in the walls. The darker areas show the building studs and structure – If there was adequate insulation, these areas would blend in more with the open voids.

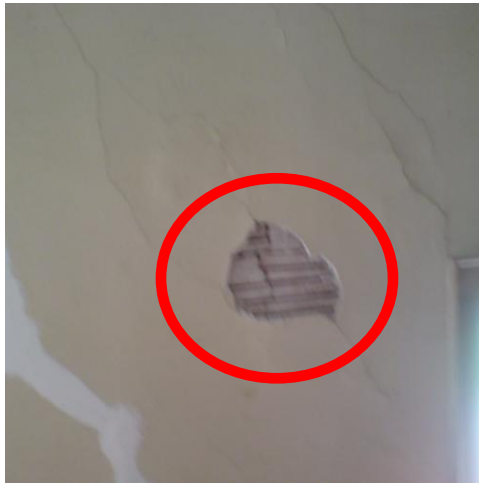
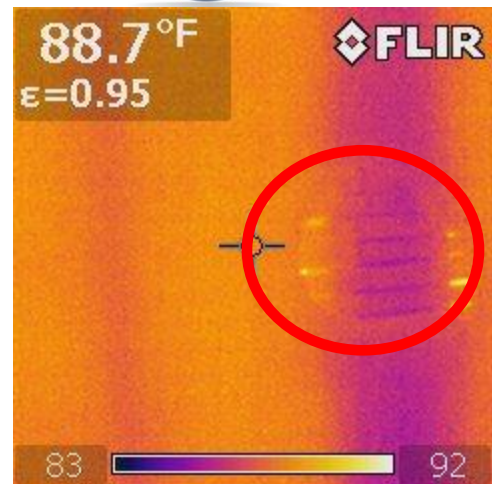
**LOCATION:** 3<sup>RD</sup> Floor Hallway

**OBSERVATION:** This picture indicates the lack of insulation in the walls. Openings in the cavity like this only further accelerate energy loss.

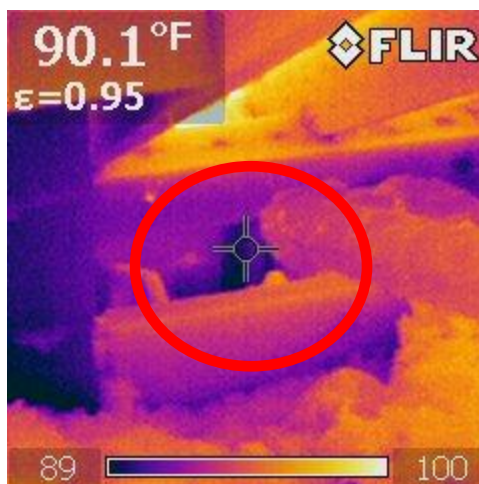
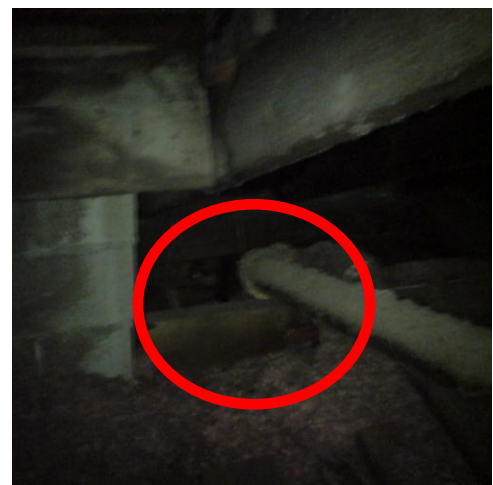
**LOCATION:** 3<sup>RD</sup> Floor Hallway

**OBSERVATION:** Because of the original construction of the building, the attic edge connects through the wall all the way down to the basement. These are large areas of energy loss and should be sealed.

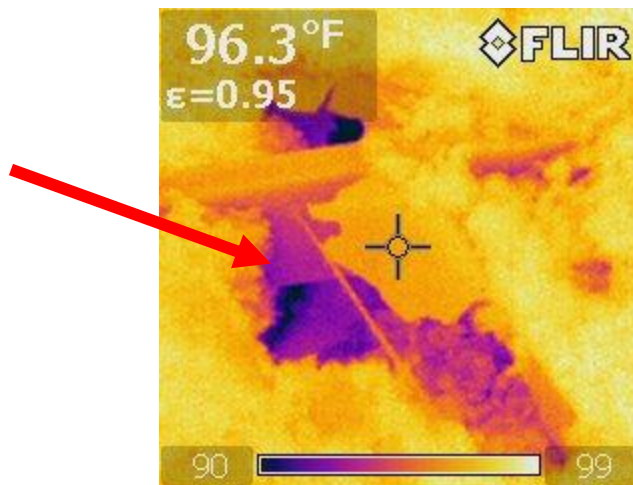
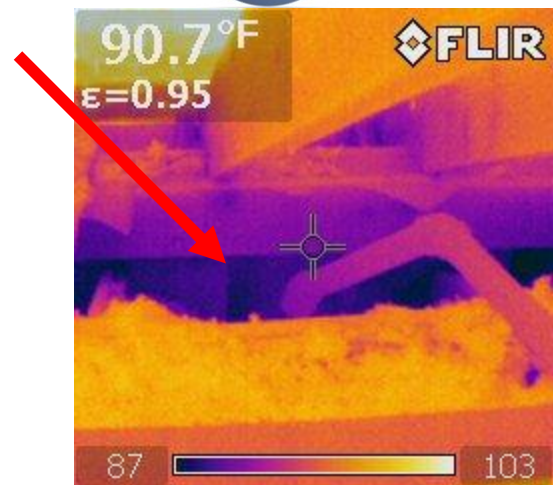
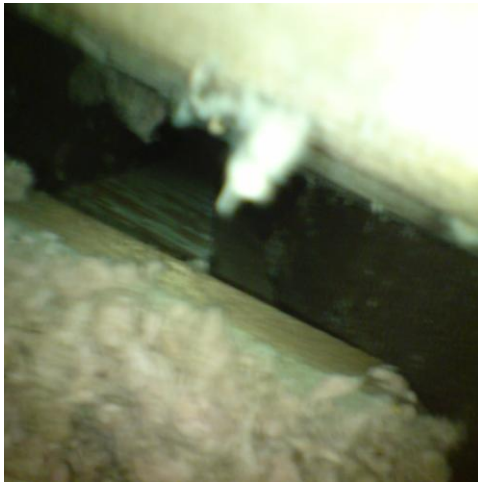
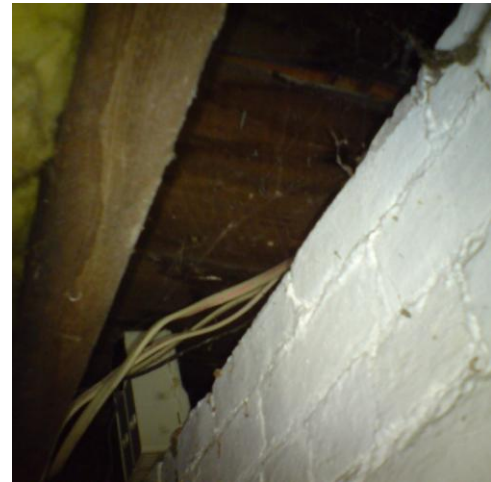
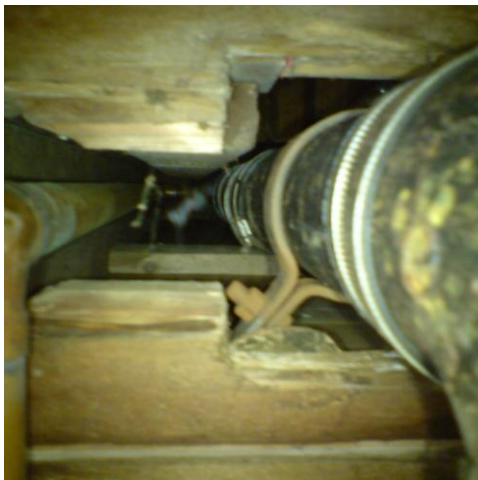
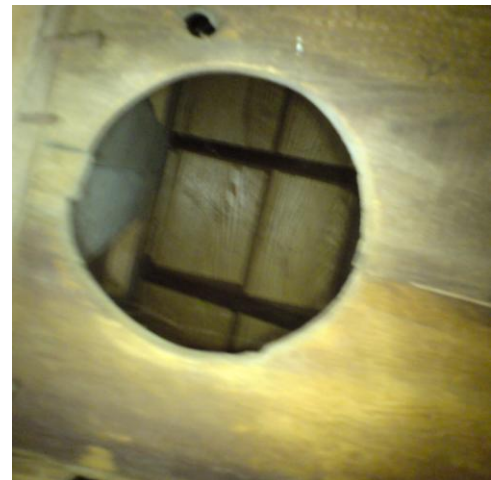
**LOCATION:** Air chutes

**OBSERVATION:** This large air chute in the attic runs down to the first floor which causes air infiltration in the building, leading to significant heat loss.

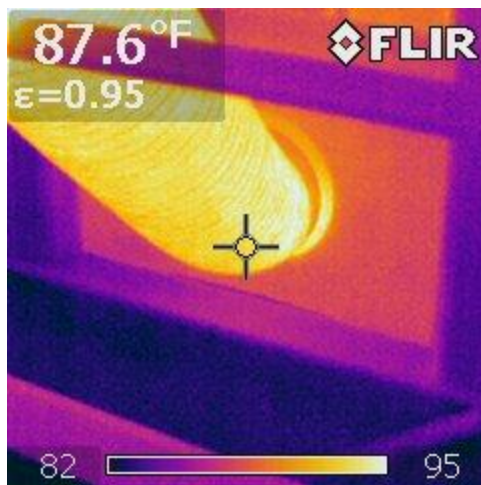
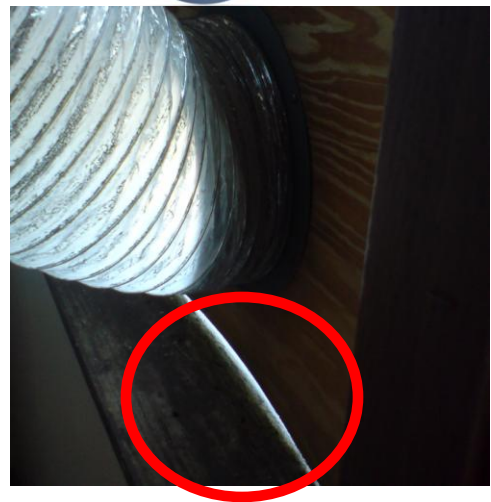
**LOCATION:** AC system on 2<sup>nd</sup> floor

**OBSERVATION:** Because the vent isn't adequately sealed, it is rendering the AC ineffective and allowing large amounts of air infiltration into the building.

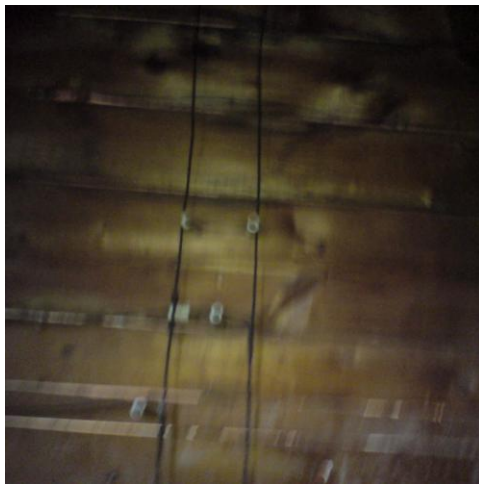
**OBSERVATION:** Knob and tube wiring (active)

Replace All Incandescent Bulbs With CFLs	\$504	-	(Electric)
Remove Knob And Tube Wiring In Attic	\$1,500	-	(Electric)
Replace Furnace And AC System	\$178,500	\$929.33-\$1,510.17	16-26% (Heating/Cooling)
