FACILITY CONDITION ASSESSMENT

TOWN OF TOPSFIELD
8 West Common Street
Topsfield, Massachusetts 01983

137641.19R000-001.322

September 10, 2019

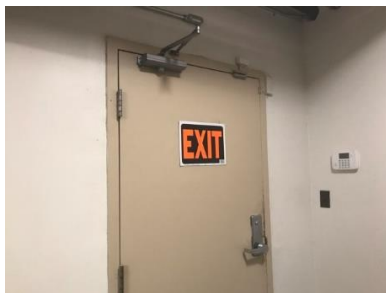
Exit Lighting Fixture in Poor condition.

w/ Battery
Police Station Throughout interior

Many of the fire exit signs are not lighted and there may be missing signs. - AssetCALC ID: 1234514

Uniformat Code: D5092
Recommendation: **Replace or install in 2019**

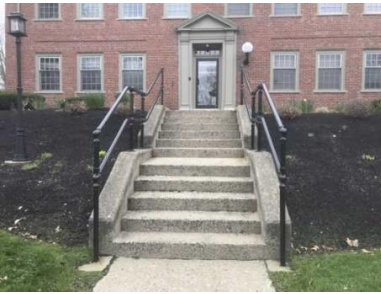
Pedestrian Pavement in Poor condition.

Sidewalk, Concrete Large Areas
Police Station Site

The sidewalks are worn and there are numerous trip hazards. The aggregate is exposed on the treads. A handicapped ramp could be constructed when the sidewalks are replaced. - AssetCALC ID: 1234474

Uniformat Code: G2031
Recommendation: **Replace in 2019**

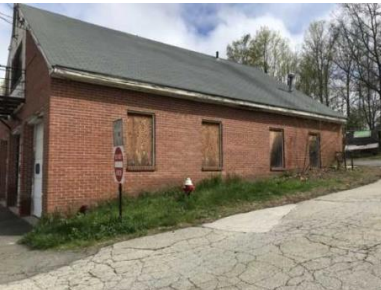
Fences & Gates

Chain Link, 6' High
Old Highway Garage Site

Due to the condition of the building and the easy access to the roof the building site should be enclosed with fencing to ensure the safety of the public using the parking lot or walking through the site. - AssetCALC ID: 1238364

Uniformat Code: G2041
Recommendation: **Replace in 2019**

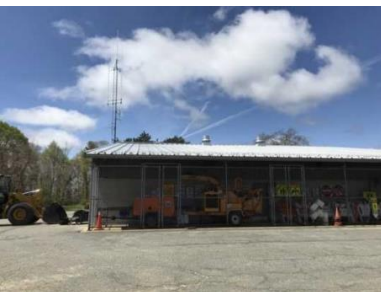
Roof in Poor condition.

Metal
DPW Building - New Roof

According to the site POC, the roof leaks at the plumbing vents, curbs and exhaust fan penetrations. Additional repairs are required. - AssetCALC ID: 1239302

Uniformat Code: B3011
Recommendation: **Repair in 2019**

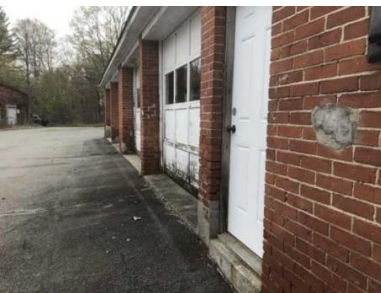
Exterior Wall in Poor condition.

Brick or Brick Veneer, 1-2 Stories
Old Highway Garage Building Exterior

The exterior brick is deteriorating. There are significant areas of missing mortar and broken, spalled brick. - AssetCALC ID: 1234379

Uniformat Code: B2011
Recommendation: **Repair in 2019**

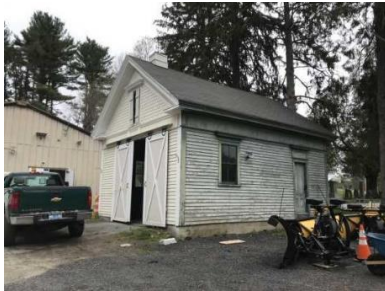
Exterior Wall in Poor condition.

Wood Shakes/Shingles, 1-2 Stories
Park & Cemetery Building Barn

The barn is scheduled to be completely renovated. - AssetCALC ID: 1234431

Uniformat Code: B2011
Recommendation: **Replace in 2019**

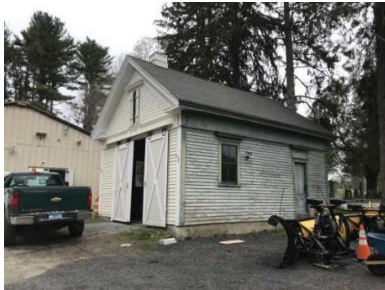
Roof in Poor condition.

Wood Shake/Shingle
Park & Cemetery Building Barn

The barn is under contract to be renovated and turned into a chapel for the cemetery. The work is scheduled to begin in June 2019. - AssetCALC ID: 1234422

Uniformat Code: B3011
Recommendation: **Replace in 2019**

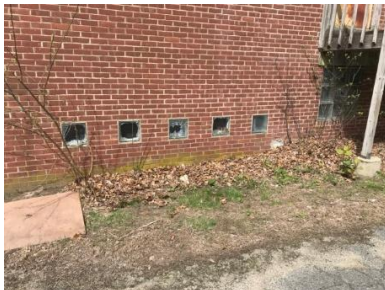
Exterior Wall in Poor condition.

Glass Block
Old Highway Garage Building Exterior

The glass block at the opening at the building are broken in most places and immediate replacement is recommended. - AssetCALC ID: 1234415

Uniformat Code: B2011
Recommendation: **Replace in 2019**

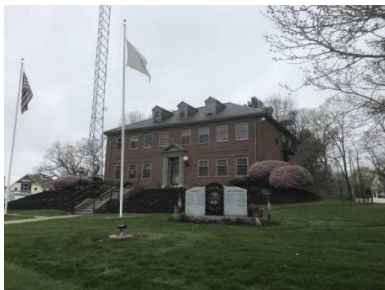
Roof in Poor condition.

Slate
Police Station Roof

The slate roof is aged and require replacement. The snow guards are corroded and according to the site POC, pieces are falling from the roof. The top floor ceilings and walls are leaking at the dormers and the chimney indicating that the flashing may be compromised. - AssetCALC ID: 1234518

Uniformat Code: B3011
Recommendation: **Replace in 2019**

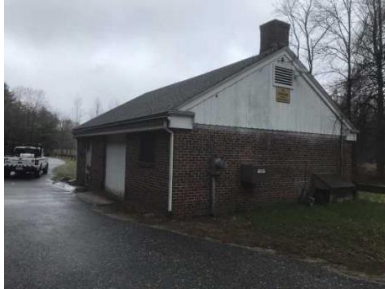
Roof in Poor condition.

Asphalt Shingle
Water Pump Station - Perkins Roof

The roof needs to be replaced. The shingles are damaged and brittle. - AssetCALC ID: 1234751

Uniformat Code: B3011
Recommendation: **Replace in 2021**

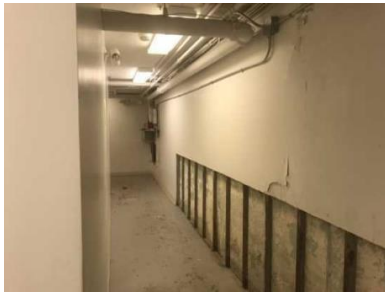
Basement Wall

Waterproofing of Exterior Face
Library Basement

Due to flooding at the basement, waterproofing along the foundation walls is recommended. An engineering study is also recommended to determine the exact cause and location of the infiltration. - AssetCALC ID: 1279276

Uniformat Code: A2022
Recommendation: **Replace in 2019**

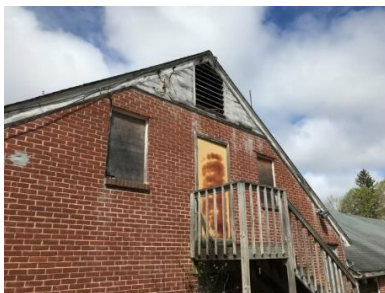
Window in Failed condition.

Vinyl-Clad Double-Glazed 12 SF, 3+ Stories
Old Highway Garage Building Exterior

The windows are broken or boarded up. This building is not occupied and is only used for storage. - AssetCALC ID: 1234414

Uniformat Code: B2021
Recommendation: **Replace in 2019**

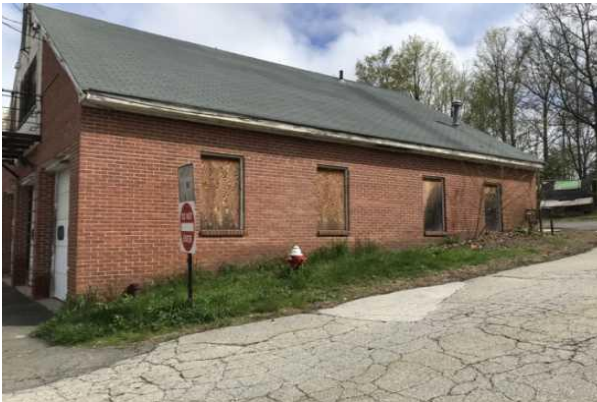
#9	BROKEN WINDOWS AT RIGHT ELEVATION
----	-----------------------------------

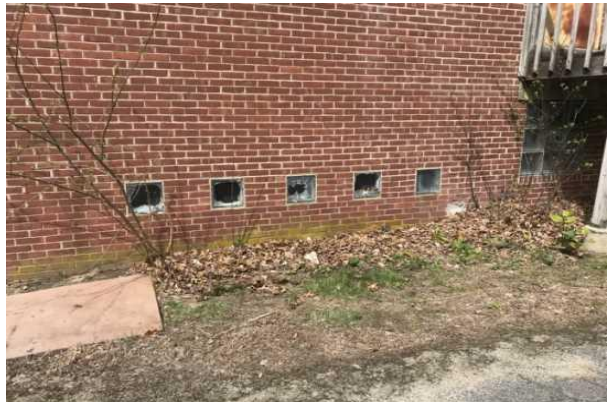
#10	BROKEN GLASS BLOCK OPENINGS
-----	-----------------------------

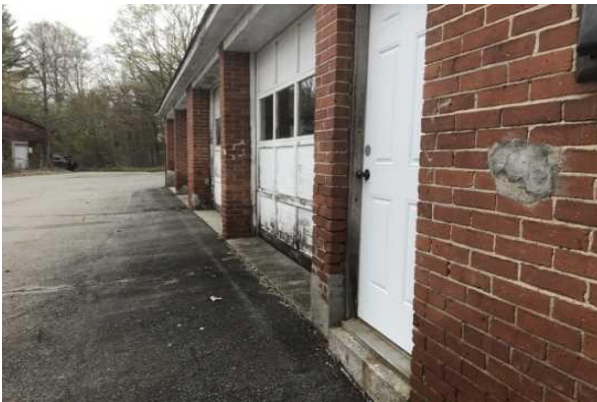
#11	DAMAGED BRICK VENEER
-----	----------------------

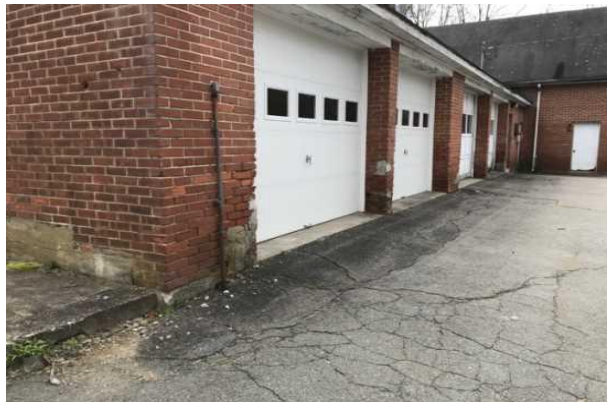
#12	DAMAGED FAÇADE
-----	----------------

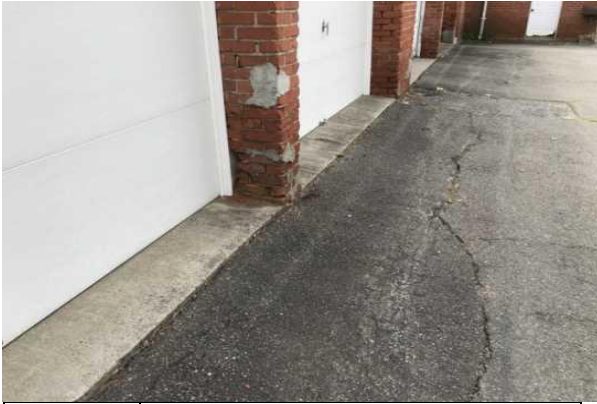
#13	DAMAGED PILASTERS AT GARAGE DOOR OPENINGS
-----	---
