TOPSFIELD TOWN HALL

Past, Present and Future

PAST REPAIRS AND THEIR PRESENT CONDITION

PRESENT CONDITIONS

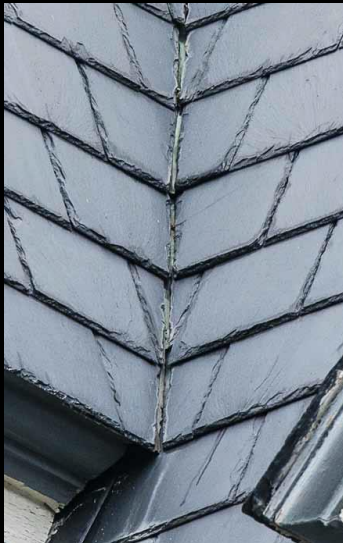
ROOF

The slate roof was replaced, perhaps in the 1950's, and the banding of the original design was not recreated. Further work was done on the roof in 2003 in connection with gutter replacements. The slate appears to be black Monson, and it is largely in good condition with a few broken or missing slates. Some valley flashings cause leaks under certain conditions.

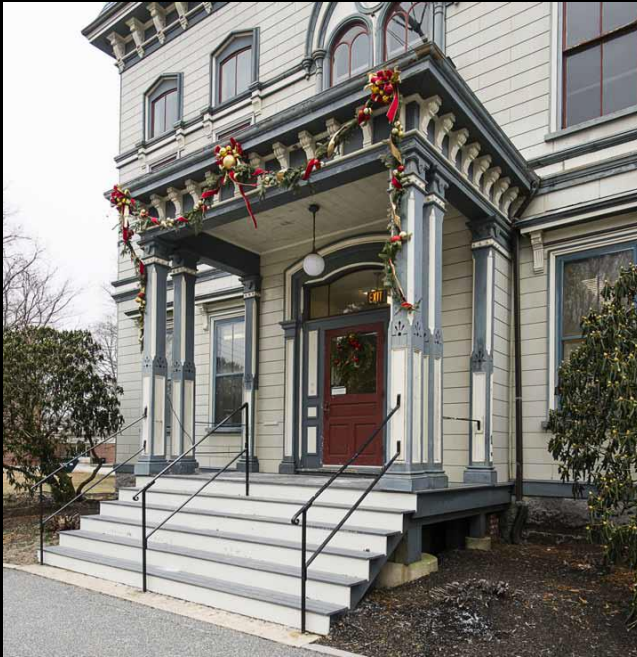
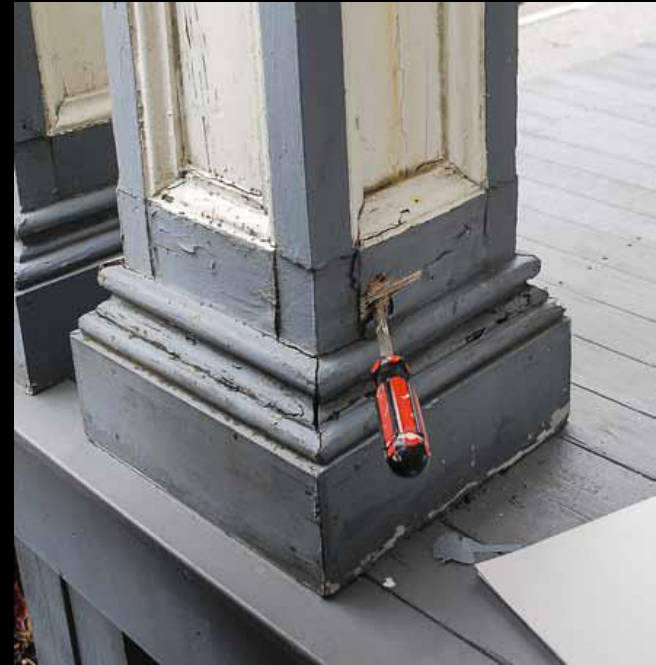
EXTERIOR WORK

Repair work in the 1990's included reconstruction of the front porch. The front porch has lost a column from the clusters of three which originally marked its corners, and the pyramid of steps on three sides has been reduced to a single flight in front.

Many of the trim elements now show signs of significant rot, especially at the bases of the columns.

Rotted elements on the front façade will be replaced or repaired.

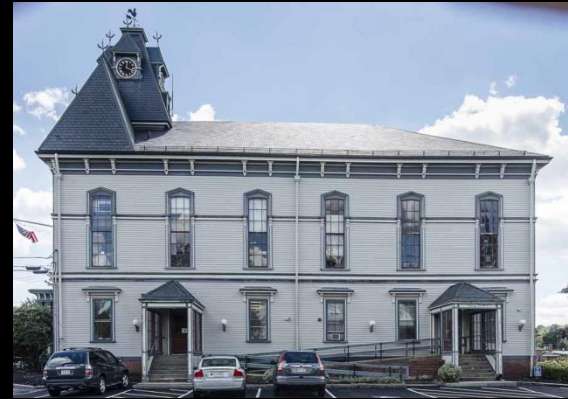
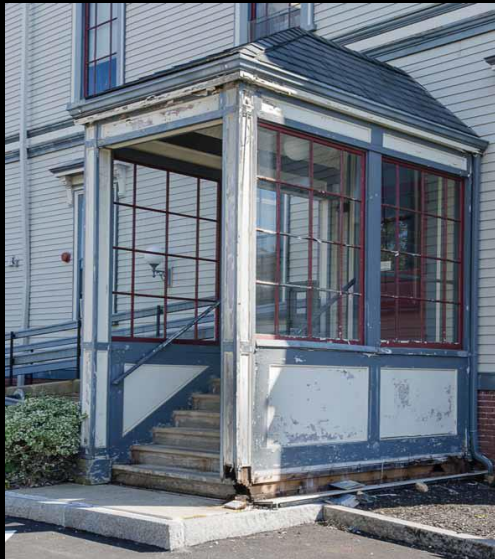
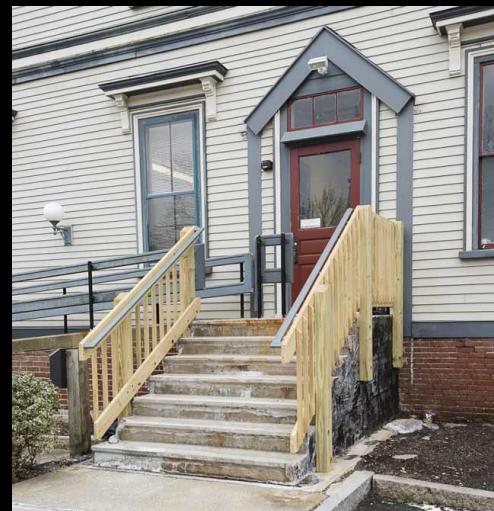
EXTERIOR PROJECTS

Repair work in the 1990's included reconstruction of the front porch and the construction of semi-enclosed vestibules over the exterior landings and steps at the north side entrances. One of these vestibules was demolished in 2014 because it was in danger of collapsing. The second will be removed this spring for the same reason.

The remaining north-side exterior vestibule – or “dog porch,” as it is called – will be removed.

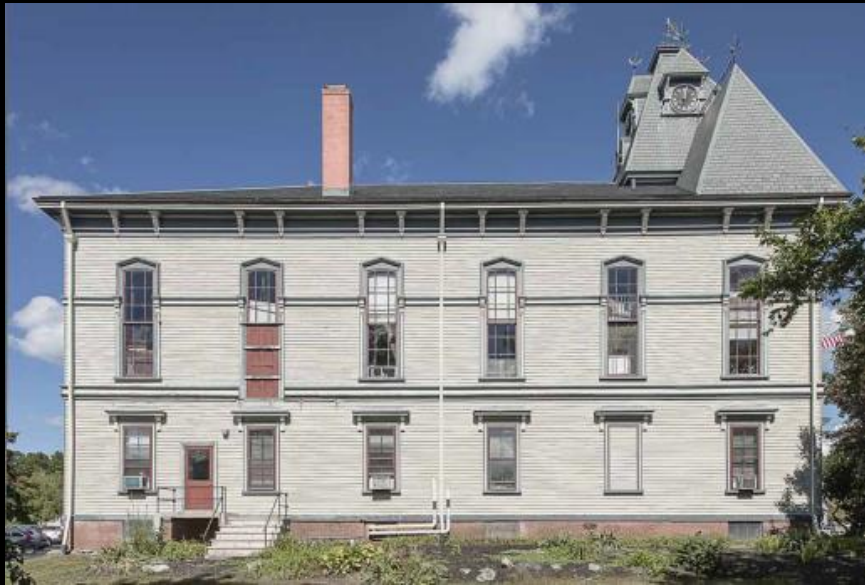
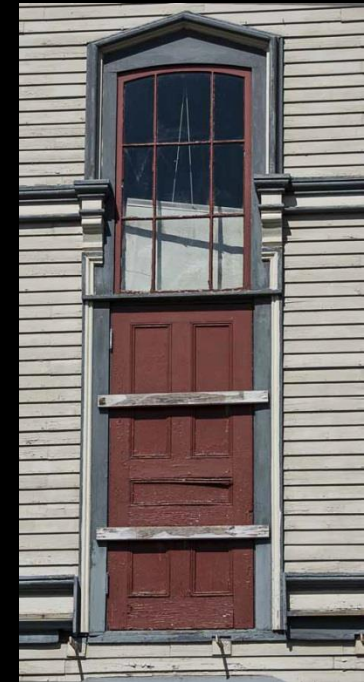
EXTERIOR SIDING, GUTTERS, AND PAINTING

The Town also received matching grants from the Massachusetts Historical Commission and the Department of Housing and Community Development to undertake preservation and repair projects. A significant project in 2003 included re-siding of much of the building, gutter replacement, repairs and painting that recreated the original color scheme. More than ten years later, this work is in good condition with the exception of the paint that has, as one would expect, begun to fail in many areas.

During this project, the fire escape was removed from the south side façade. It was not replaced in anticipation of future renovations to Town Hall. The second floor door is secured by exterior bars. The first floor door shows significant deterioration.

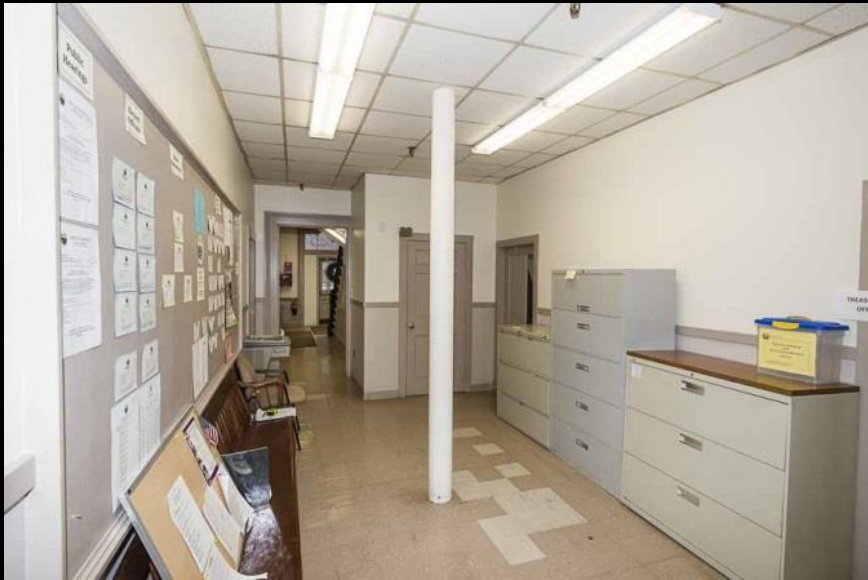
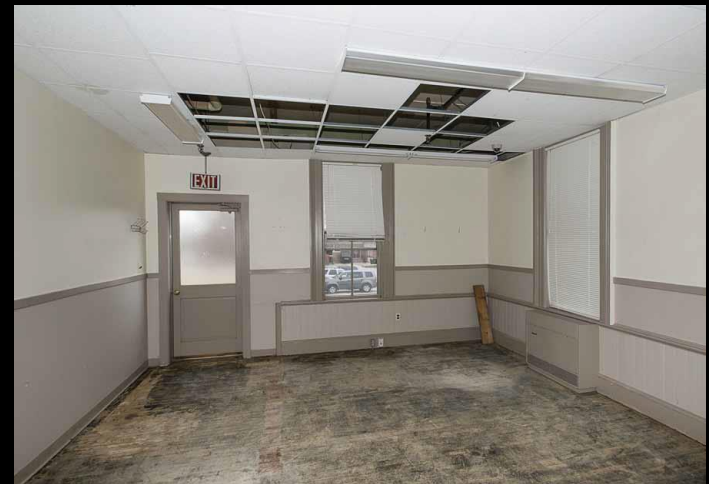
PAST INTERIOR WORK

At some point, a suspended ceiling was added to the first floor, and the original wooden floor was covered with vinyl tile. In another round of work, the vinyl tile was covered with carpeting in office areas. Over time, some of the tiles have been replaced. The tiles are asbestos vinyl tiles that are cracking and breaking, especially in areas prone to regular flooding from leaks. The carpeting is split and worn. One of the main support pillars for the building rises in the middle of the main hallway on the first floor.

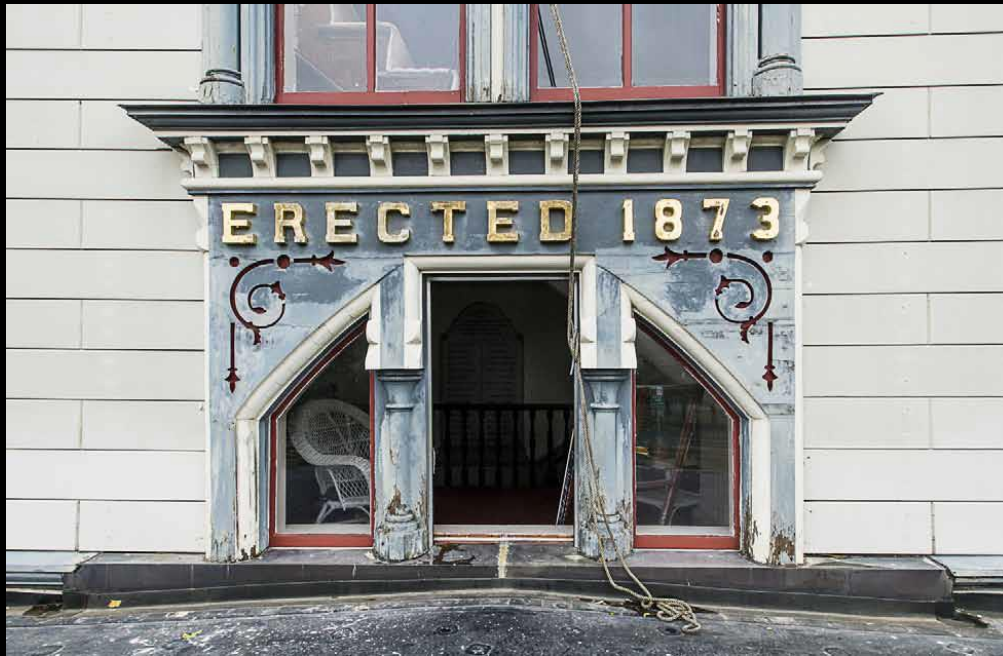
This picture captures where we are. The original structure is sound and stands as testimony to the quality of construction over 140 years ago. On the other hand, deterioration has set in throughout the building. Here, above the front portico, the central window and trim features are rotted. This area lets water in. The water finds its way through the emergency exit light to flood the front foyer where the asbestos vinyl tiles have lifted. A rubber mat covers the gap in the tiles.

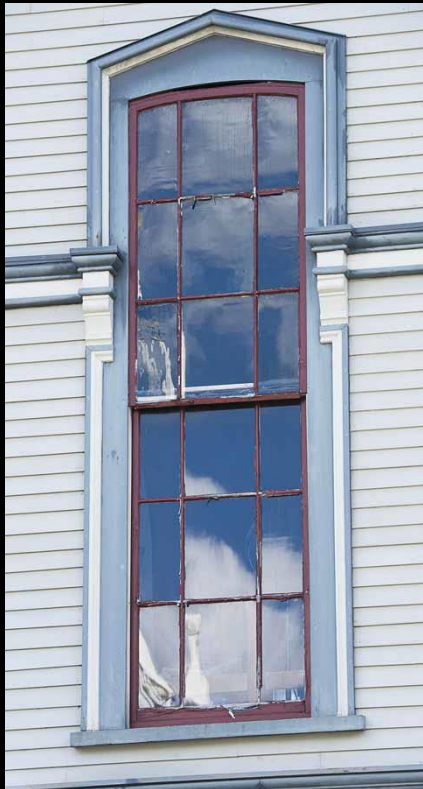
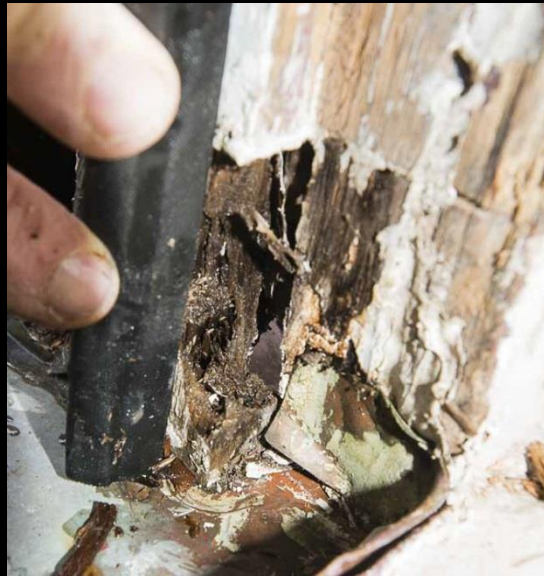
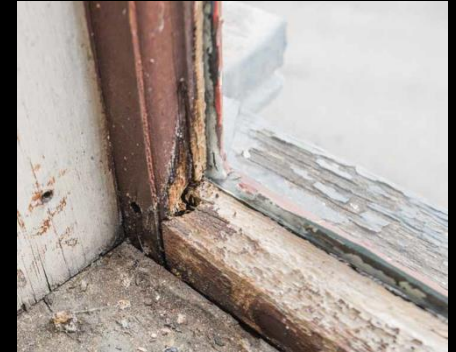
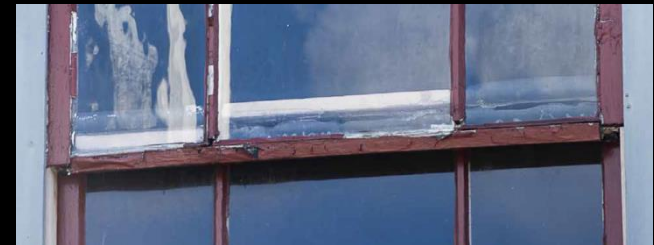
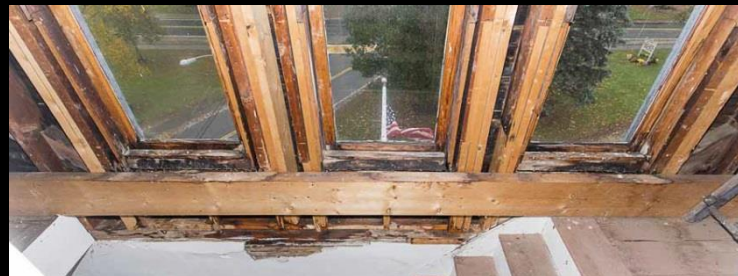
WINDOWS

Windows throughout the building are in poor condition. Last winter, a pane fell out of one on the second floor, exposing a heating pipe that froze and then burst, flooding the Treasurer's office. Other second floor windows have been secured with plywood and/or duct tape to hold them in place.

Windows will be repaired or replaced, depending on the severity of their condition. Storm windows will be added to the second floor windows to protect them from the elements and to improve the energy efficiency of the building.

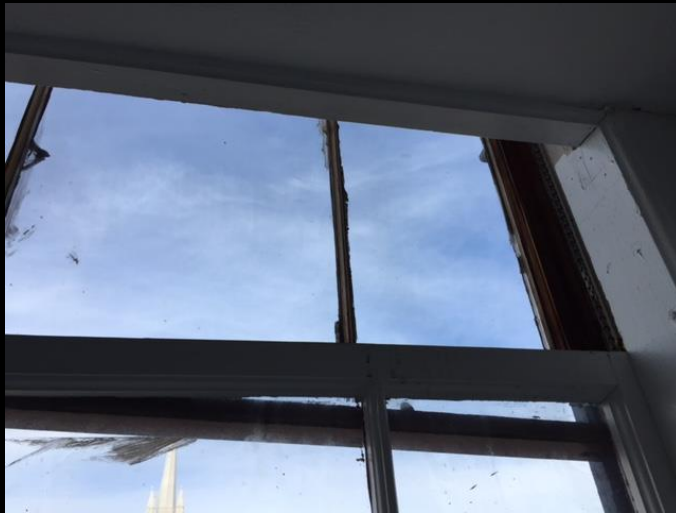
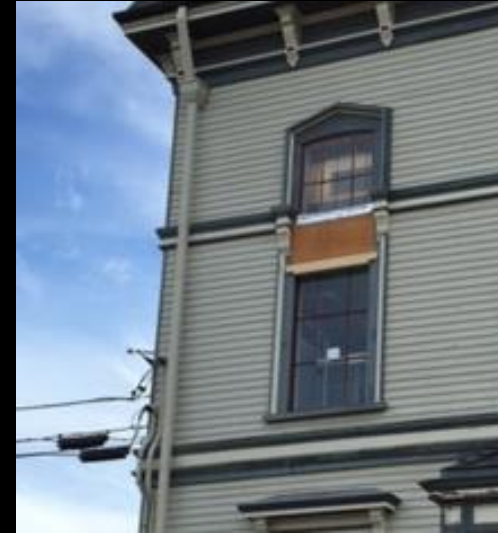
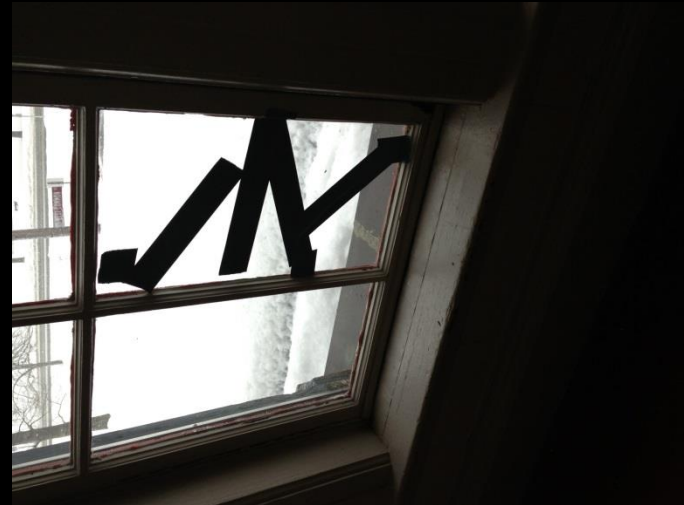
WINDOWS

Other second floor windows have been secured with plywood and/or duct tape to hold them in place.

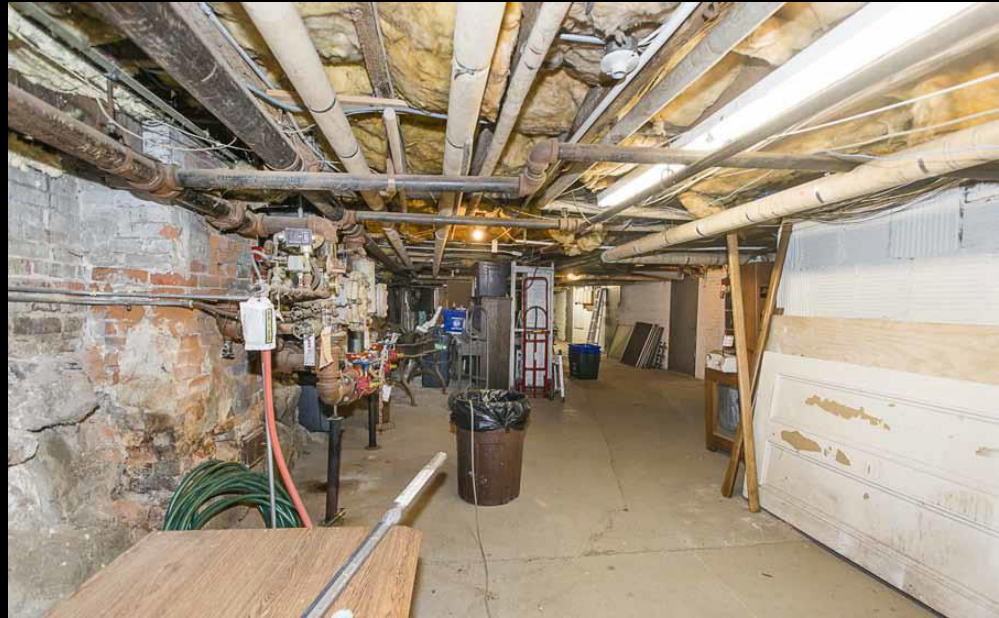
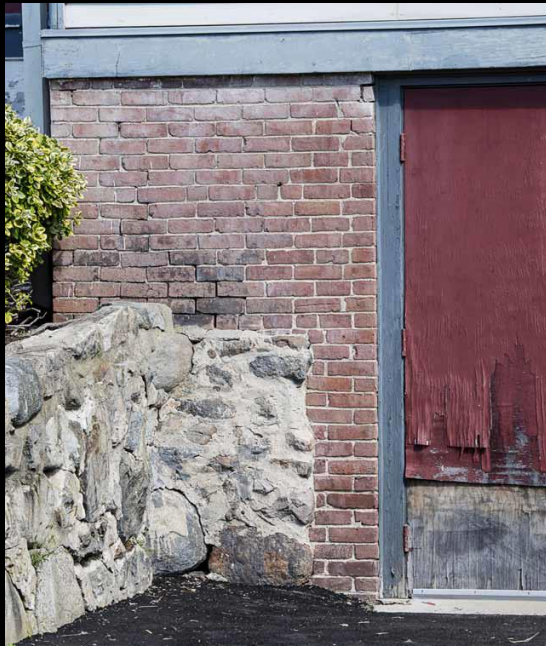
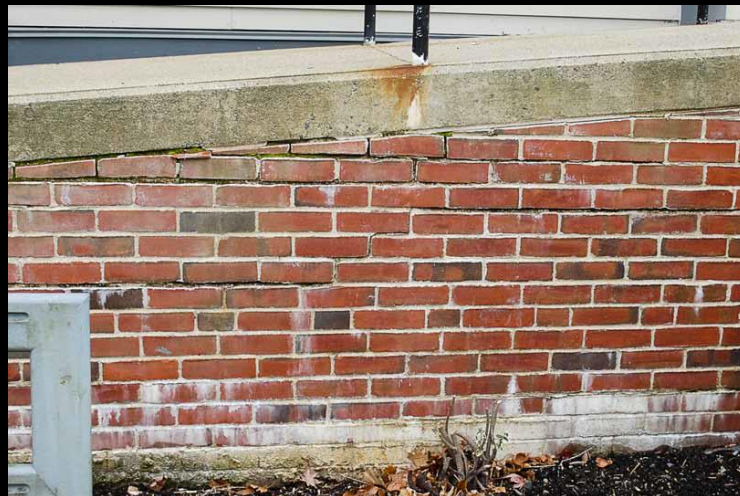
FOUNDATION

This interior photo shows the fieldstone foundation below grade and the brickwork above grade. The brickwork shows defective mortar joints.

The foundation will be repointed.

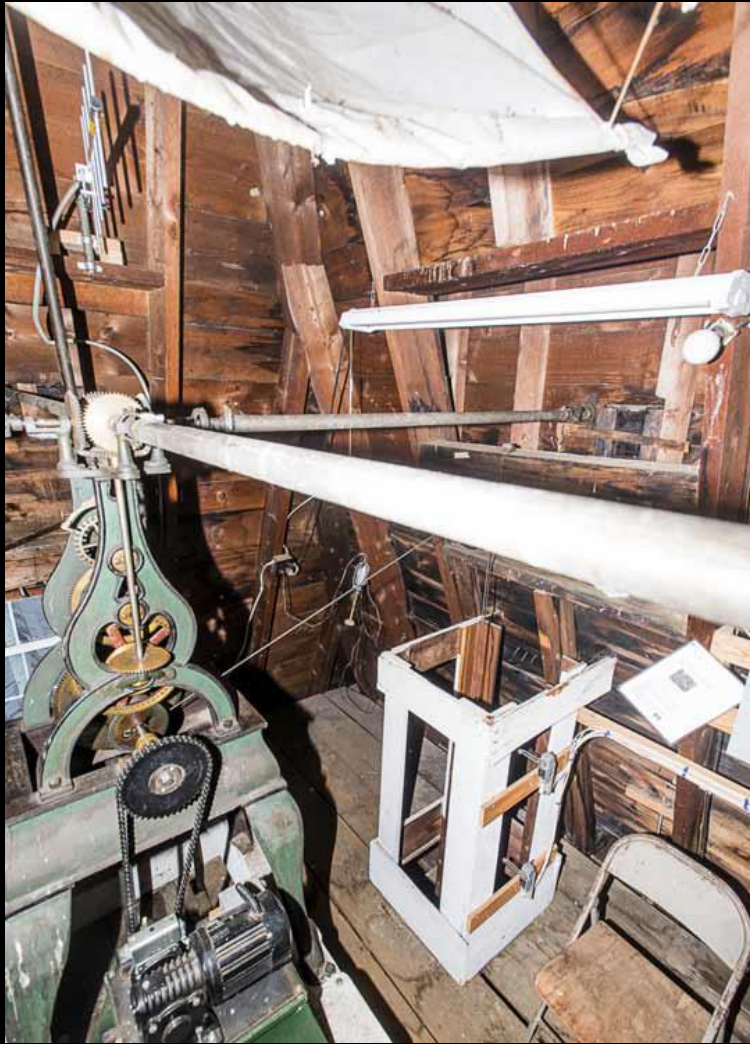
INTERIOR OF CLOCK TOWER

The top level of the clock tower houses the clock mechanism shown here. The horizontal shafts link the clock movement to the clock faces. A sheet of plastic has been set up to protect the clock mechanism from occasional leaks coming from the top of the tower.

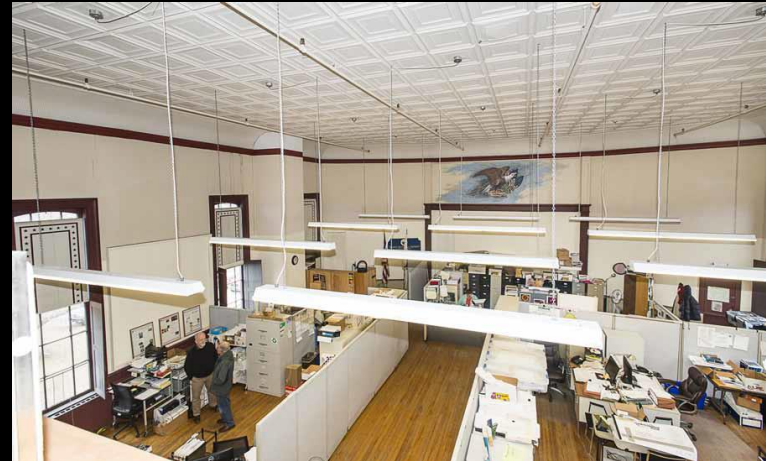
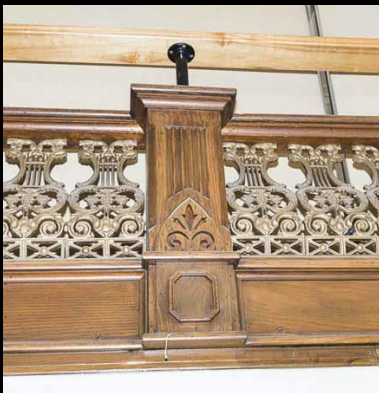
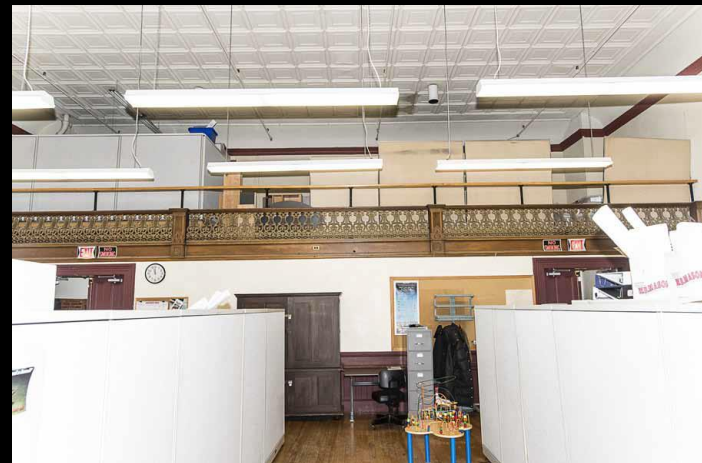
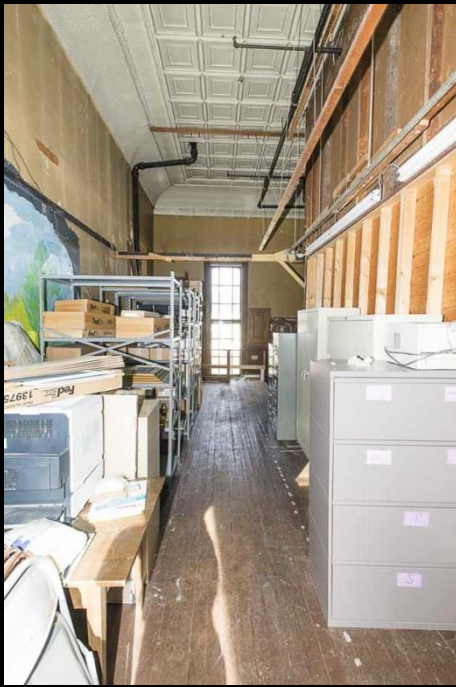
THE AUDITORIUM TODAY

The auditorium has been sectioned off with partitions to accommodate various Town offices, including the Board of Health, Inspectional Services, the Conservation Commission and the Veterans' Agent.

The walls throughout the meeting hall are covered with paper that has been painted. The paper is stained and starting to lift at its joints.

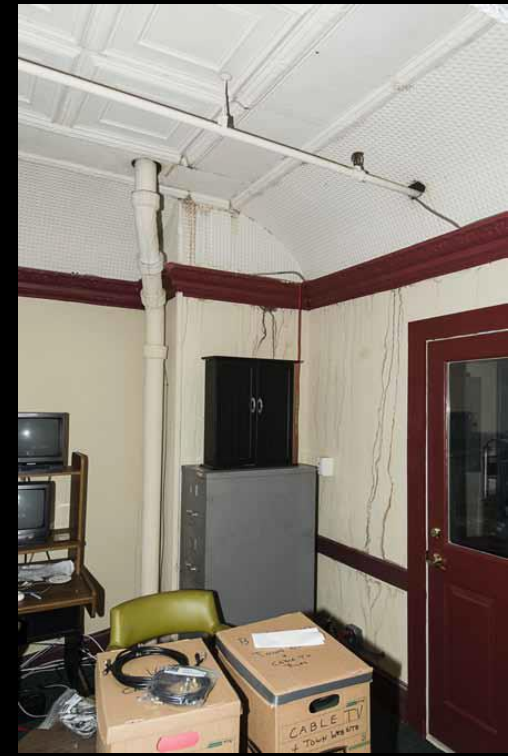
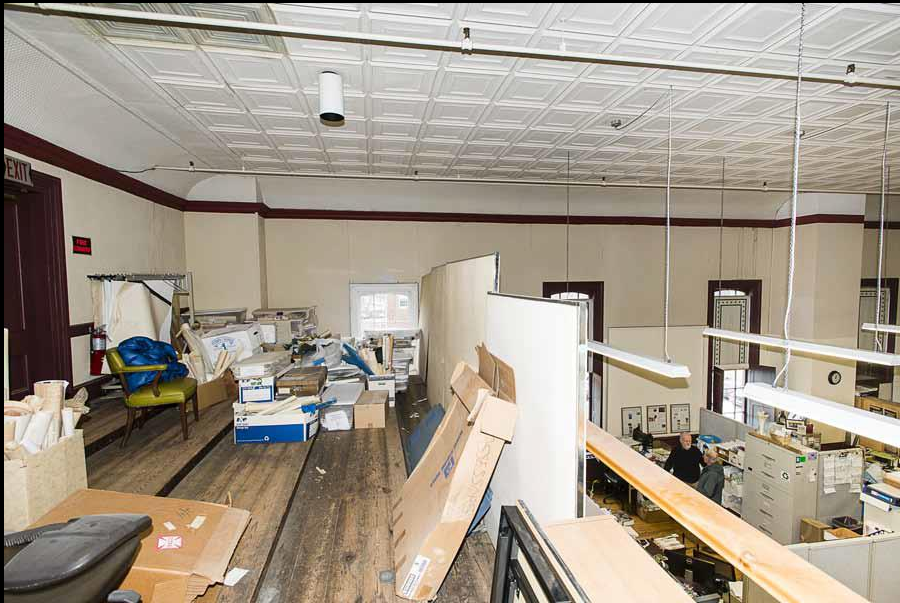
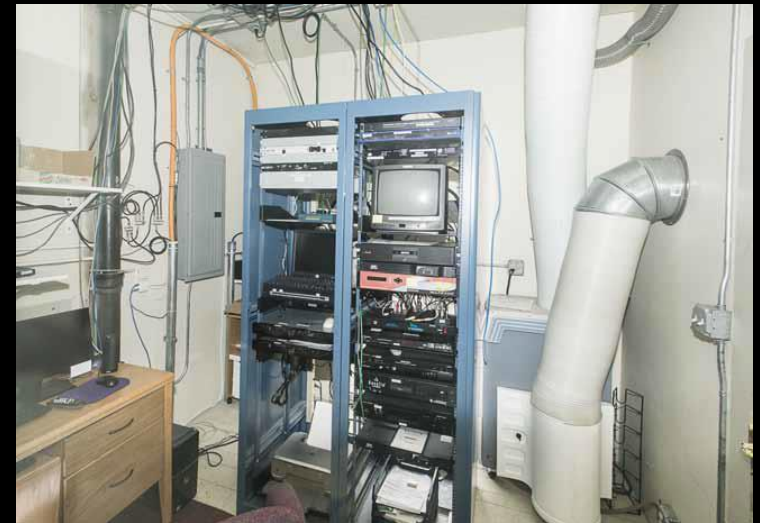
THE BALCONY AND STAGE

The balcony and stage areas are used for storage. Old water stains mark the walls. Cable TV equipment occupies a portion of the balcony level with its own HVAC equipment to maintain temperature and humidity levels.

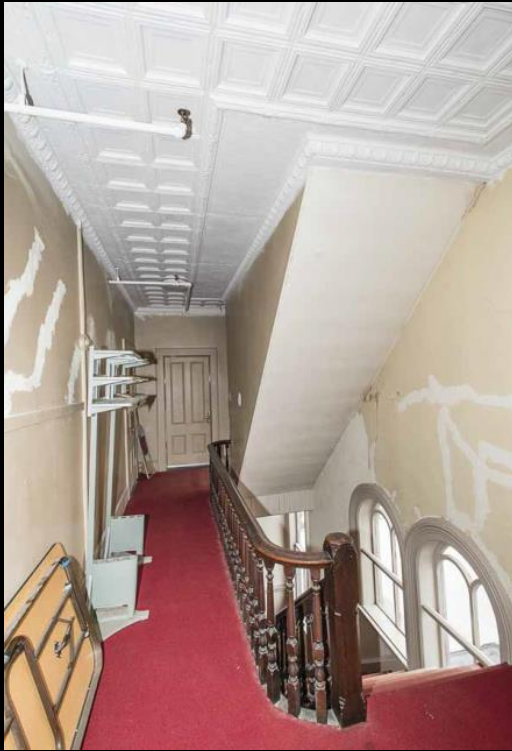
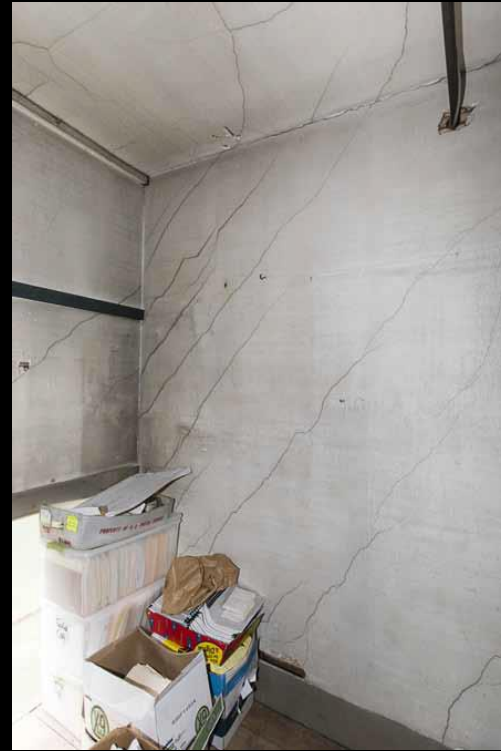
HALLWAYS AND STAIRWAYS

The plaster walls in hallways and stairways have not been painted or otherwise repaired for many years. They show cracks from long past structural movements of the building, stains from leaks, and superficial efforts to address such problems.

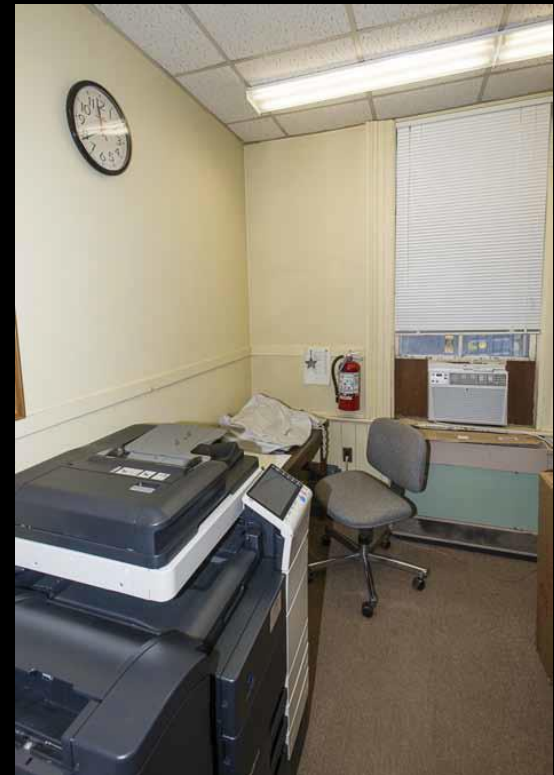
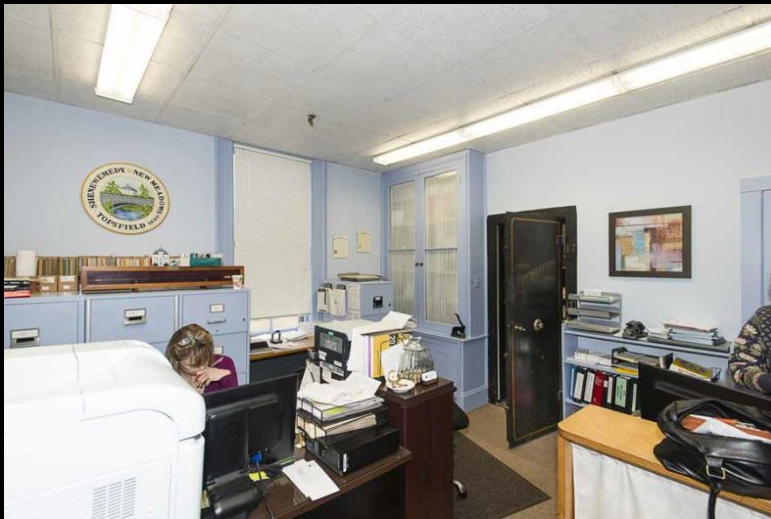
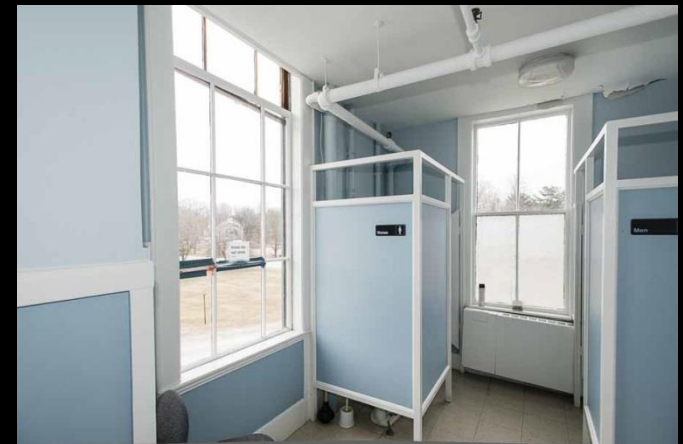
OFFICES AND FUNCTIONAL SPACE

Offices are cramped and antiquated. The server and copy room requires a window-mounted air conditioner to maintain appropriate temperatures. Bathrooms are outmoded and occupy space inefficiently. The waste pipe in the one shown here let go, soaking a storage closet in the Council on Aging office below. It was repaired but with no guarantees from the plumber that it won't happen again.

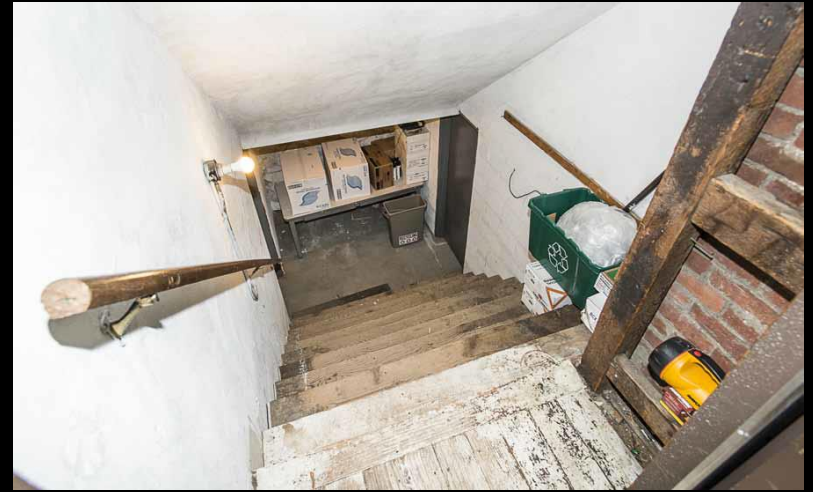
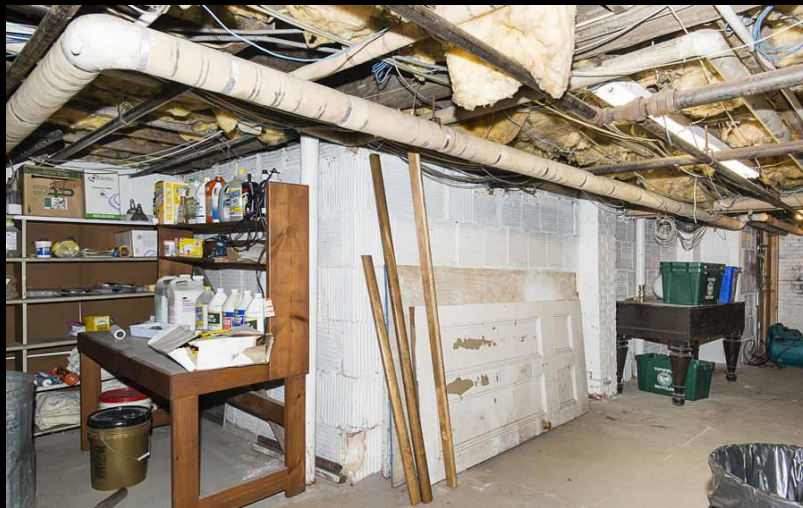
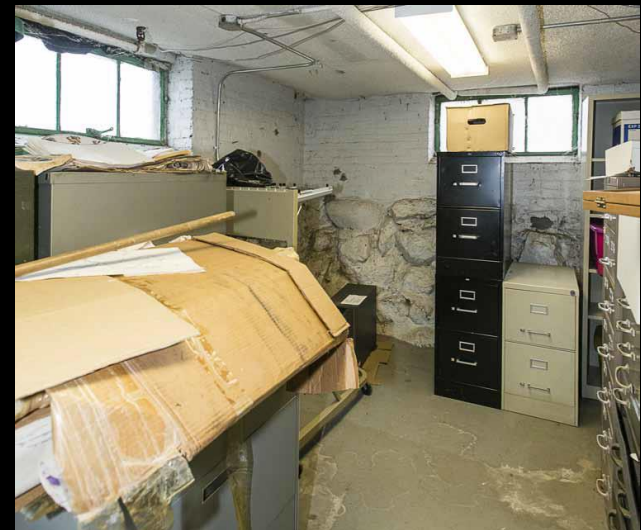
THE BASEMENT

Steep stairs lead to the basement that is used largely for storage. Water stains on the floor indicate past leaks and flooding. Various types of insulation have been used to seal the foundation from leaks and outside air infiltration.
