JOEGREEN ROADMAP TO ENERGY EFFICIENCY™

Audit Date: August 5th, 2010

Building: Proctor Elementary School

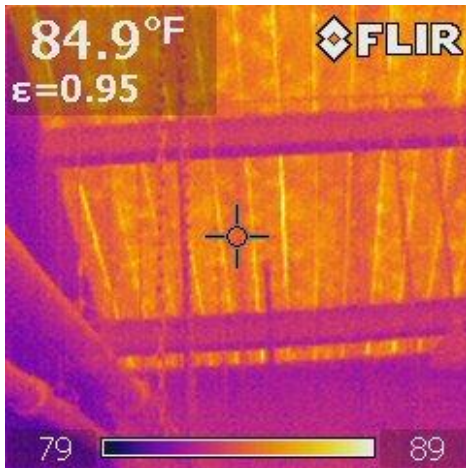
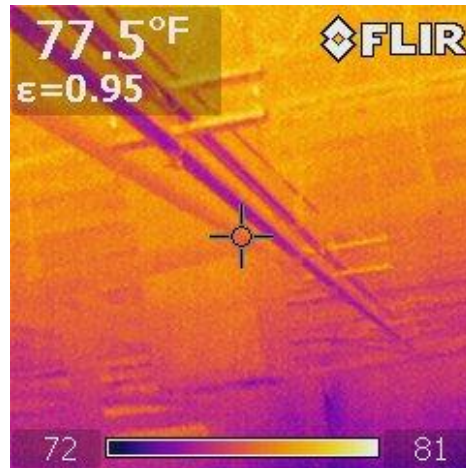
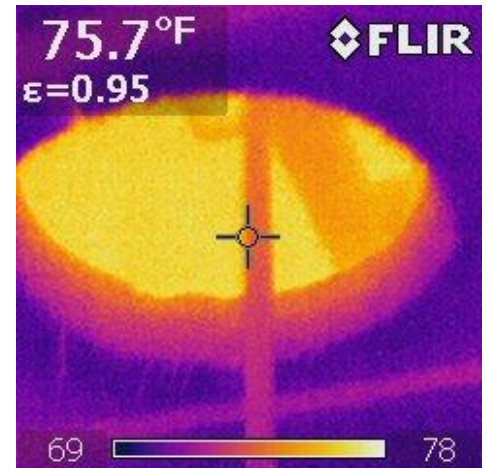
Location: Basement

Insulation Is Needed Underneath Building (Where Accessible).

Observation: These pictures show the significant heat leakage through the floor above into the basement. These areas have decent access in most areas and can be insulated.

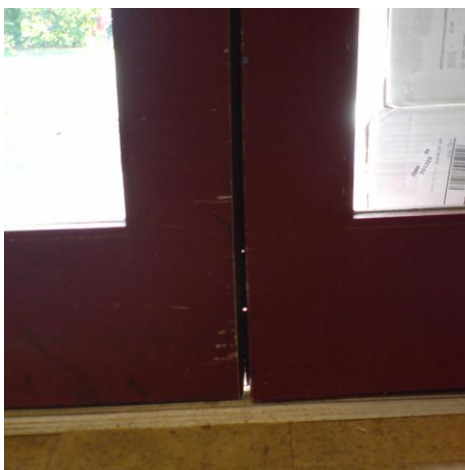
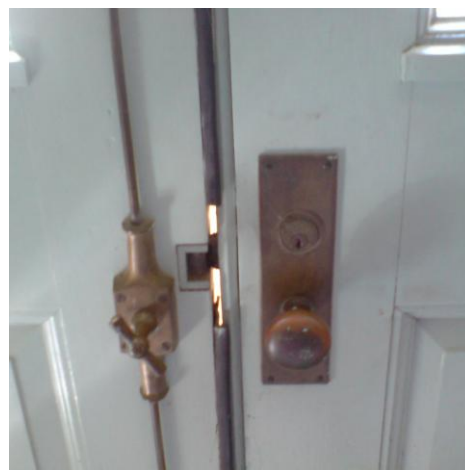
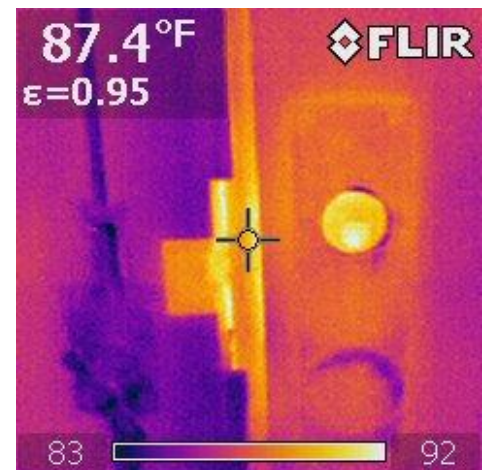
Location: Main Entrance and side entrance

Main Front Doors Need Weatherstripping.

Observation: These are pictures of the doors that need weatherstripping to reduce air infiltration. Note the daylight shown in between the doors.

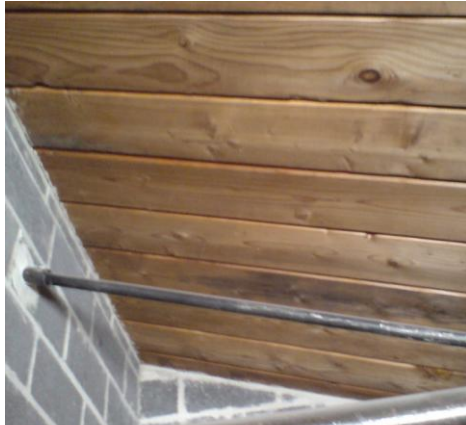
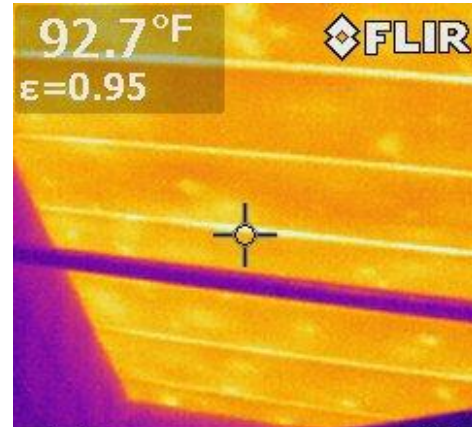
Location: Above the stage, on each side upstairs.

Both Wings On The Sides Of The Gym Need More Insulation. They Have Single Pane Windows And Direct Sun Exposure To The Air Handlers Stored There, Meaning Reduced Efficiency.

Observation: This wood is the only thing acting as insulation toward the air handlers stored in this space. This coupled with the single pane windows with excessive sunlight entering cause a large reduction in efficiency of the air conditioning.

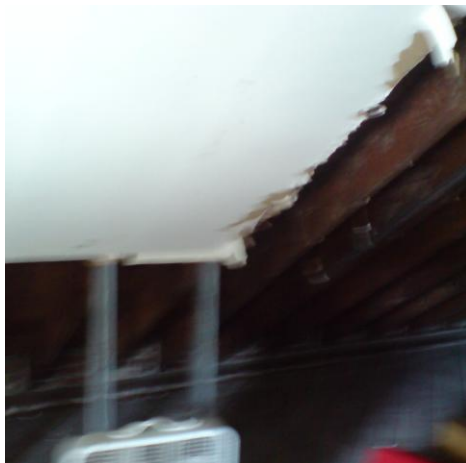
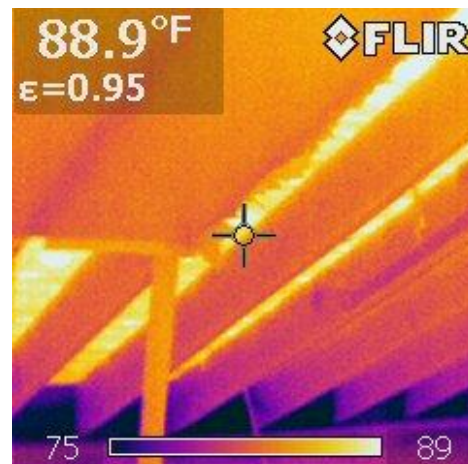
Location: 3rd Floor

3rd Floor Needs Additional Insulation And Air Sealing Along Roofline.

Observation: These are the areas along the roofline that have little to no insulation, and are connected directly to the conditioned spaces on this floor.

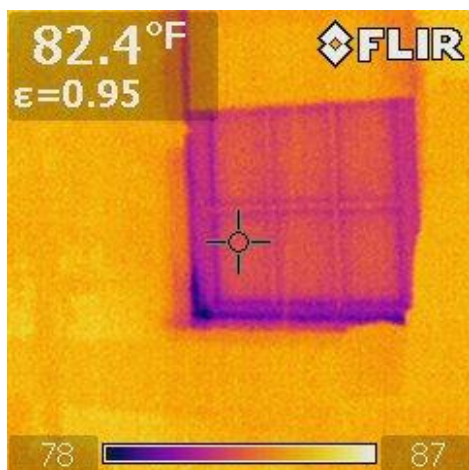
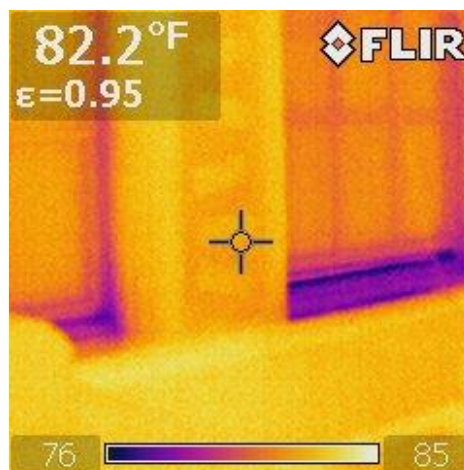
Location: Throughout building

Some Of The Windows Are Unlatched, And It Is Difficult To Tell Whether They Are Latched Properly Without Checking Carefully.

Observation: These air leakages on the corners of the windows are caused by not properly shutting and latching the windows. More leakage can be felt along the top of the sash as well.

Many of the “Pella” windows that have been installed are difficult to latch, and it is hard to tell if they have been latched properly without close inspection. Particular care should be taken that these windows are latched, as this is a very cost effective way to reduce potential heat loss.

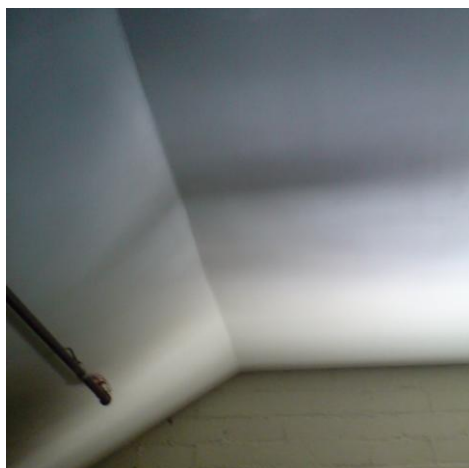
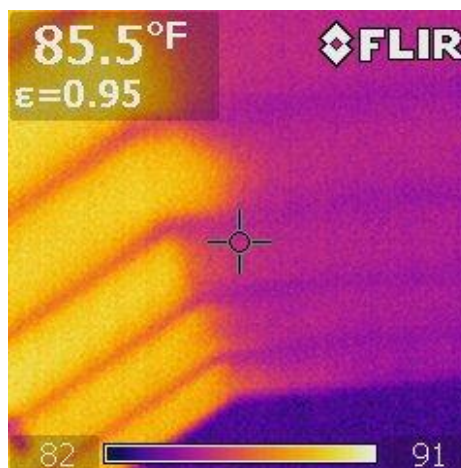
Location: 3rd Floor Roofline

Observation: Another example of inadequate insulation along the roofline of the building.
