**Topsfield Town Hall  
Window and  
Envelope Study**

# Topsfield Town Hall Window and Envelope Study

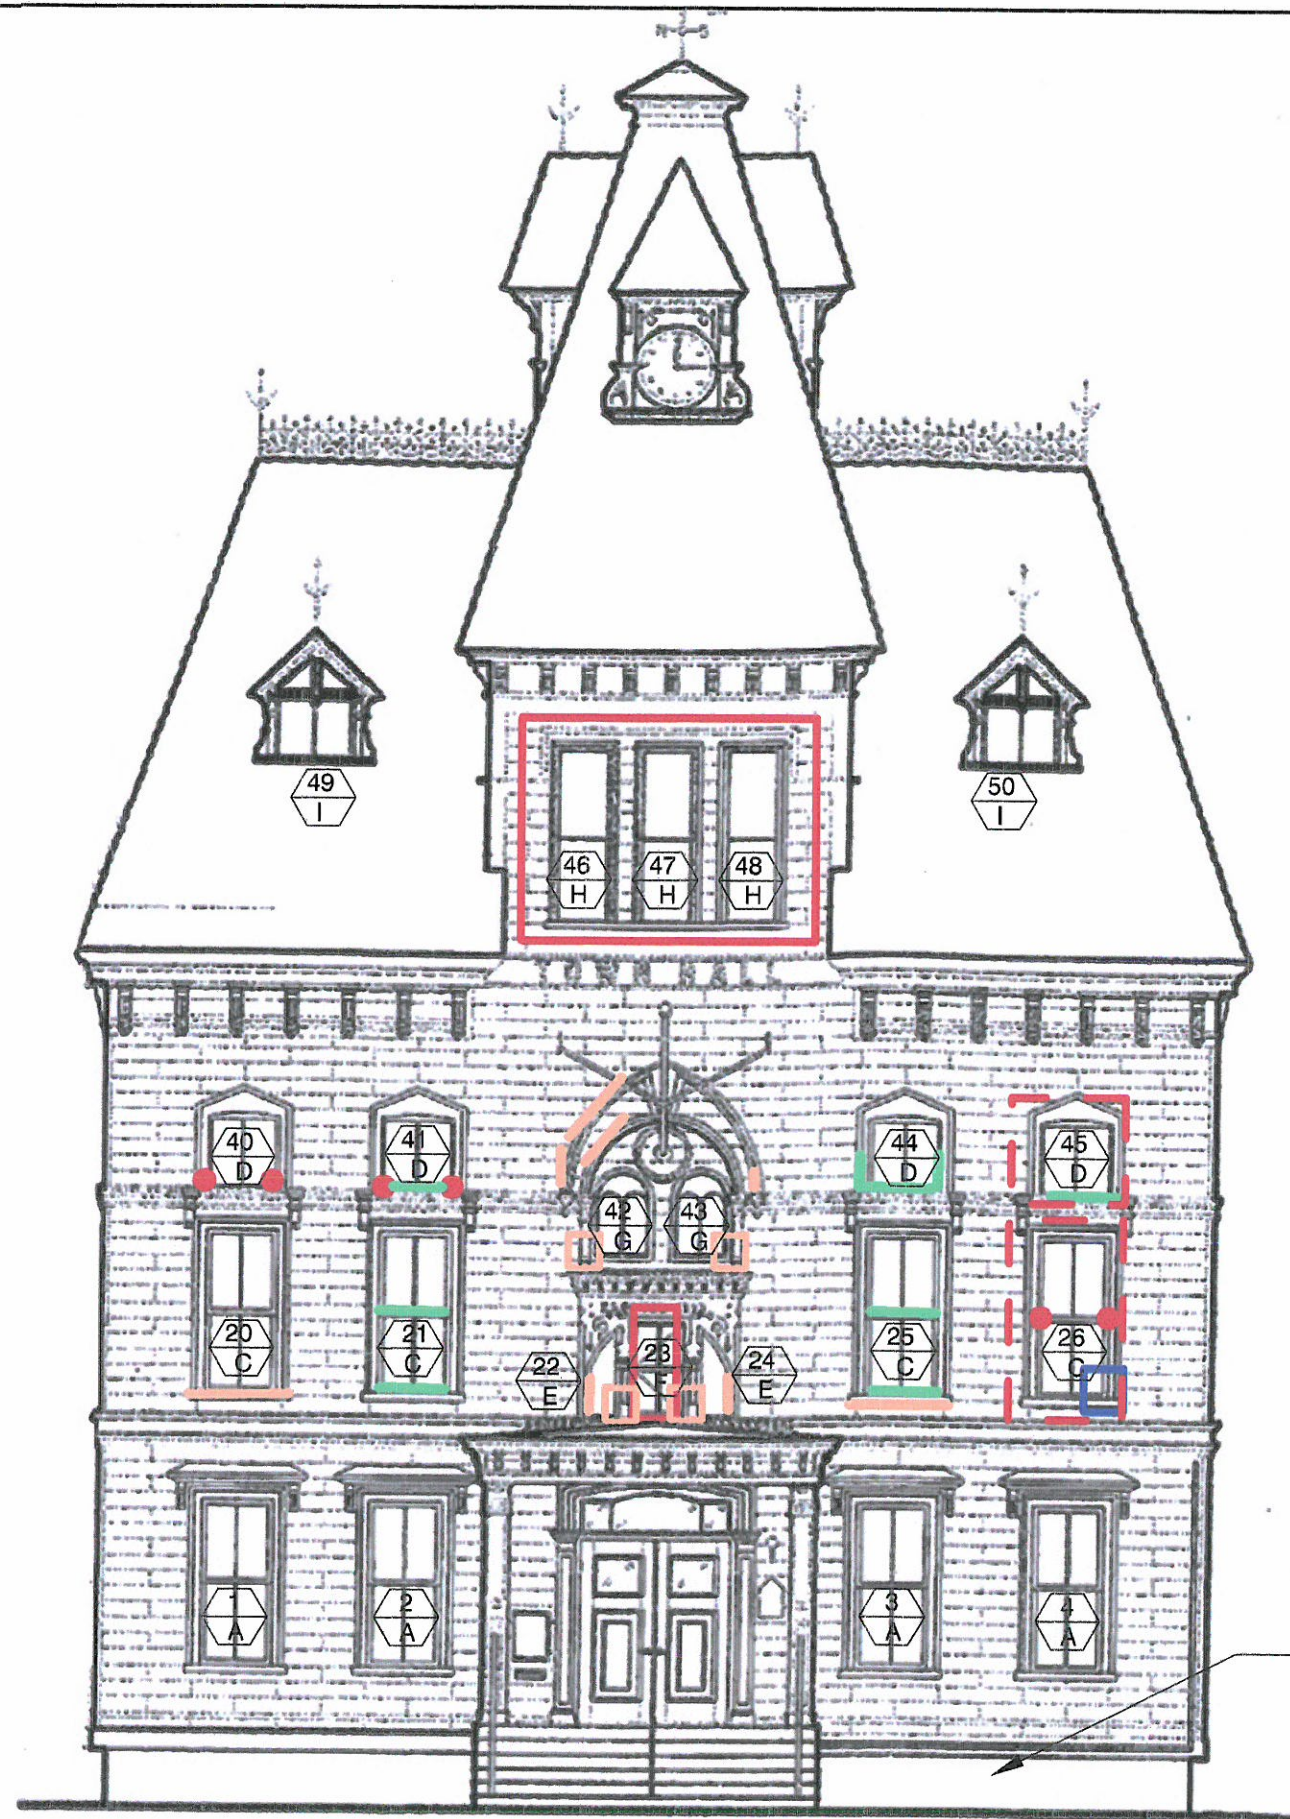
**A-2**

- Possibly replace indicated sash if repair proves not feasible
- Replace indicated sash
- Checks in rail: Epoxy conserve
- Checks in stile: Epoxy conserve
- Dropped or open corner joint: Rescure rail at joint
- Rot at corner joint: Epoxy conserve and/or Dutchman repair
- Checks in casing or molding: Epoxy conserve
- Badly split base molding: Replace & correct flashing

Approx 10' of mortar joints in granite should be repointed
