RE: A&M Project #2165-01A
Rolling Green Elderly Housing
Development
470 Boston Street
Topsfield, MA 01983
**A&M Response Horsley Witten
Review Letter**

**Proposed Residential Development
470 Boston Street
Topsfield, Massachusetts**

New England Environmental, a division of SWCA, Incorporated (NEE/SWCA), is pleased to provide you this report regarding a hydrogeologic evaluation of subsurface drainage conditions for the above-referenced site. The objective of the hydrogeologic investigation is to evaluate 1) subsurface soil and groundwater conditions, 2) the infiltration capacity of the soil, and 3) groundwater mounding relative to septic and stormwater infiltration systems proposed for the "Rolling Green" residential development. As part of the field investigation, three test pits were advanced to collect representative soil samples. Published information and on-site deep hole observations made by others were also reviewed to prepare a conceptual site model.

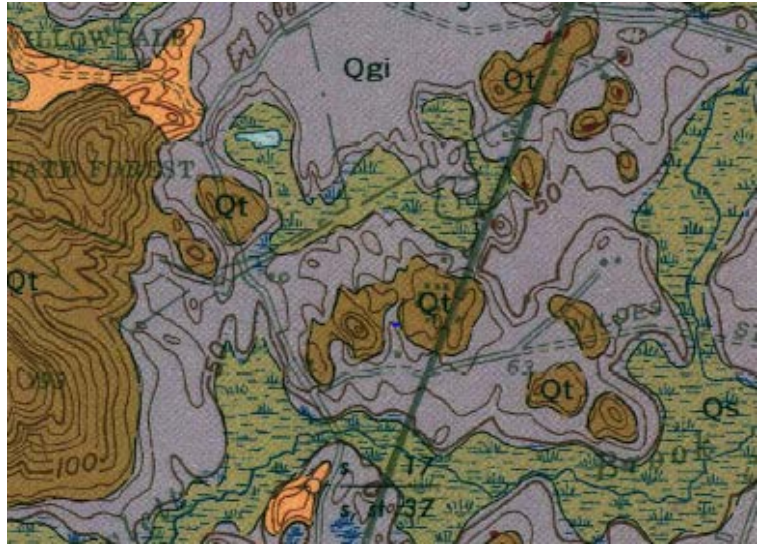
Insert 1 - Surficial Geology from USGS GQ-850 (Cuppels, 1969)

The surficial geology of the site has been mapped by USGS (Cuppels, 1969) and shows permeable outwash sand (Qgi) throughout the majority of the site. The outwash is projected to underlie wetlands to the north, and lie above a glacial till deposit that is exposed to the south of the site along the local topographic high (EI 80 to 100 feet). The wetland to the north of the site has an intermittent drainage feature that discharges to Howlett Brook, located to the south of the Site. The presence of the wetlands to the north and Howlett Brook to the south provides hydraulic relief for groundwater flow at the site.

The outwash and glacial till has been shown to have high sand and gravel content and to be crudely stratified and having moderate permeability. Bedrock is not known to outcrop in the site area. USGS has mapped the bedrock formation to be the Topsfield granodiorite (Zen et al, 1983).

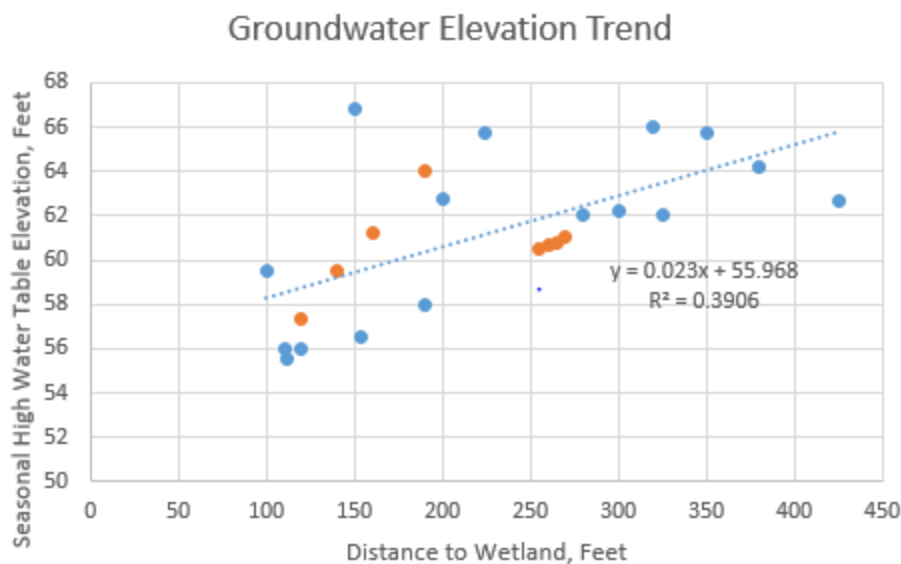
Insert 2 - Allen & Major (blue) and Eaglebrook (orange) SHWT observations from test pitting

Groundwater at the site appears to flow to the north as higher groundwater elevations (and SHWT) trend to the south, and mirror higher ground surface elevations. Below, the SHWT elevation for the various test pits have been plotted versus distance to the wetland boundary. The overall trend suggests a 1 to 3 percent gradient exists. Variability properties within the outwash and till leads to scatter of the data. As expected, the groundwater data supports that the bordering wetland to the north serves as a constant head boundary, providing hydraulic relief for the site.

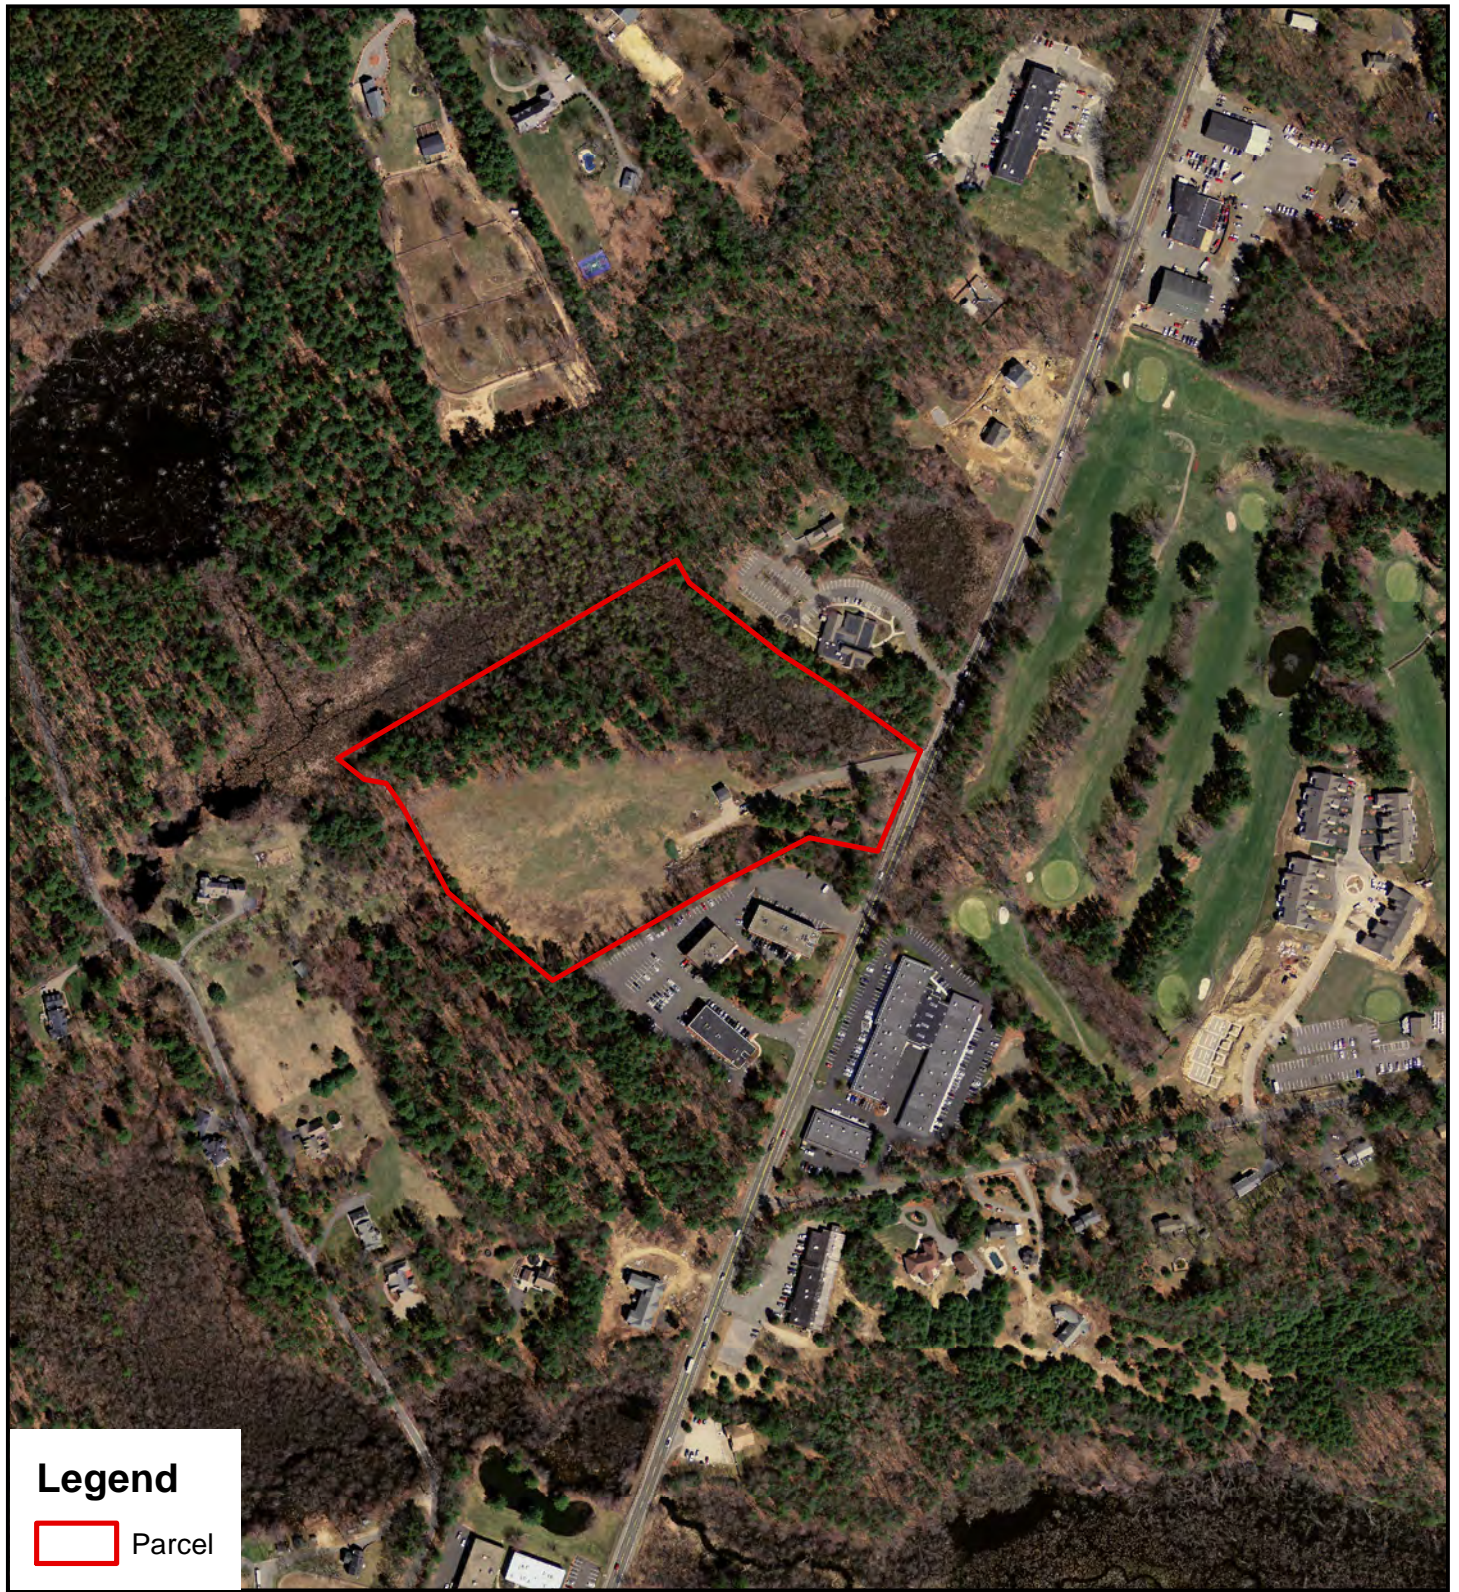
| Figure 3 | Subsurface Exploration Location Plan |

The location of the test pits and infiltration features are shown on **Figure 3 Subsurface Exploration Location Plan**, and are based on plans prepared by Allen & Major as well as Eaglebrook.

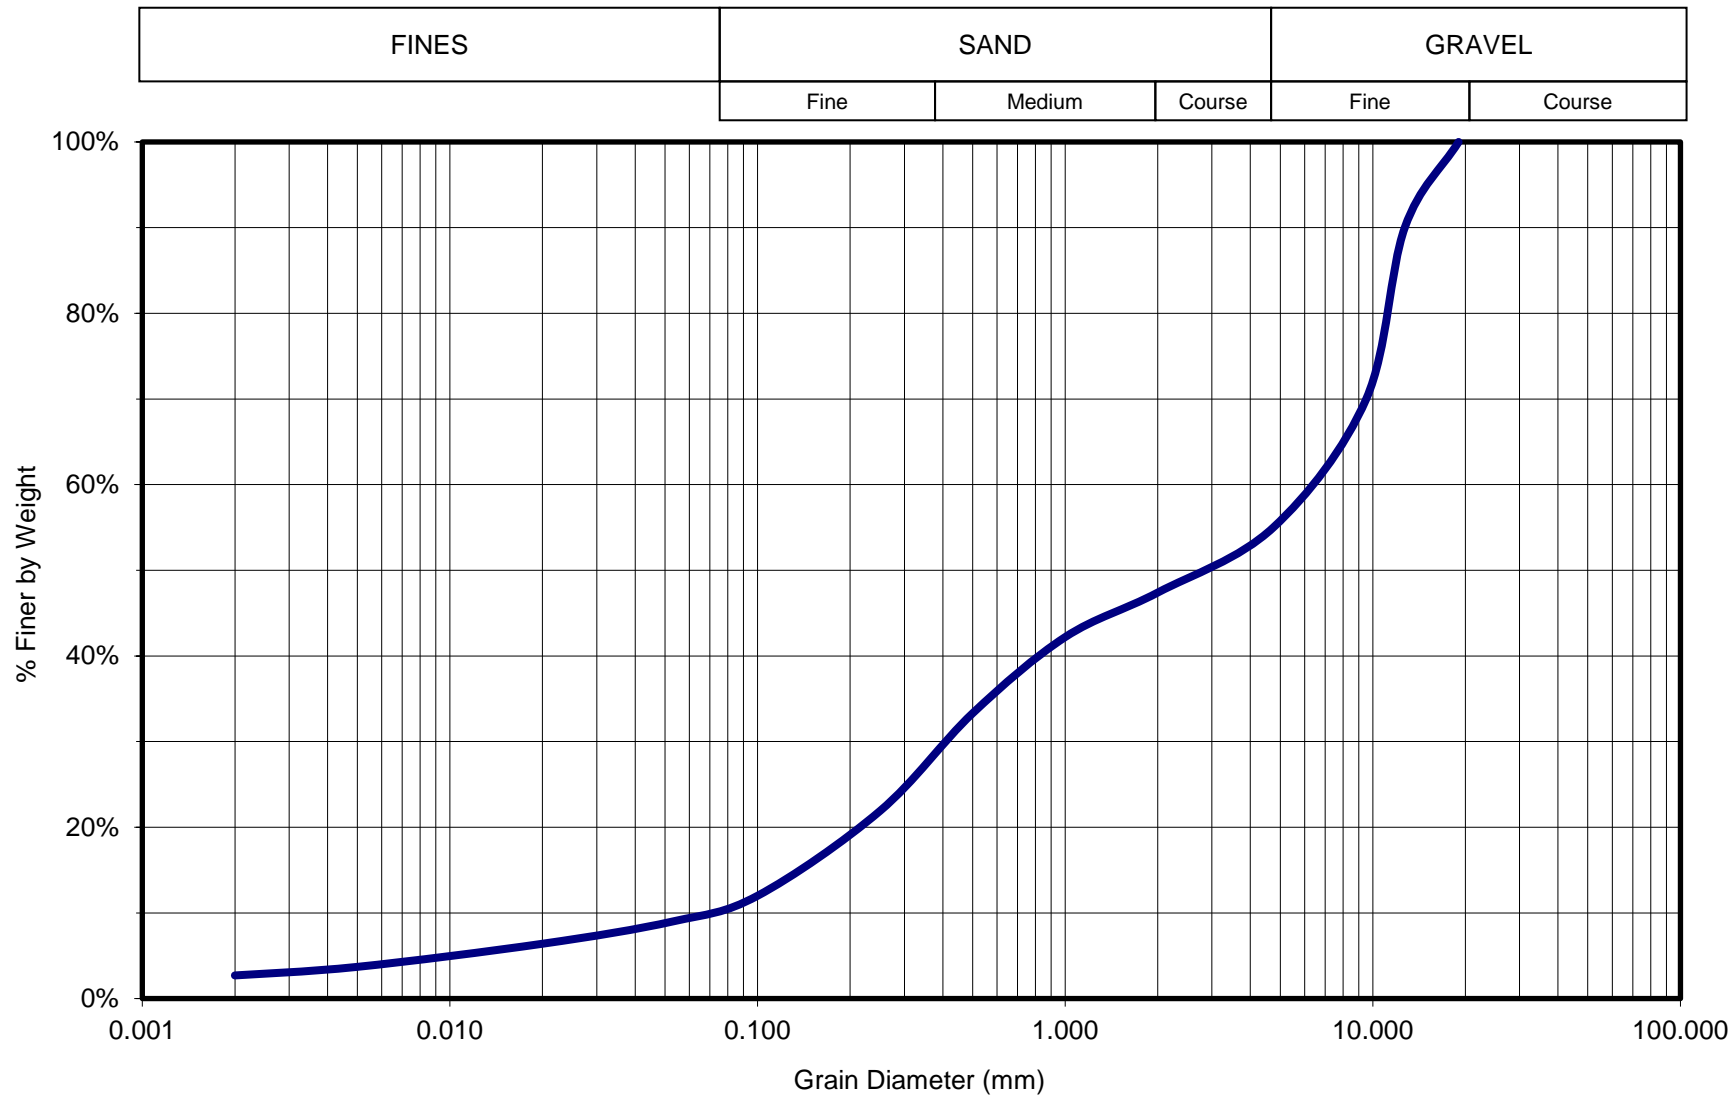
Grain size analysis for SWTP1, 8 to 9'

USDA Textural Class: gravelly loamy coarse sand

Gravel Content: (%) 52.6

where D_{10} is in millimeters. A summary of the hydraulic conductivity estimates are provided in **Table 1**. A mean hydraulic conductivity of 20 feet/day was obtained for the overburden soils. It should be noted that the range of hydraulic conductivity for soils is the greatest of any single soil parameter. Large deviations in hydraulic conductivity within a given soil deposit are common. Also, a number of uncontrollable factors influence the results of tests designed to measure hydraulic conductivity. Therefore, the results of these tests should be considered to be only an indicator of the soils hydraulic conductivity and not an absolute value. Additionally, actual hydraulic conductivity values are known to be 10 times or more in a horizontal direction versus the vertical direction, especially in the presence of stratification.

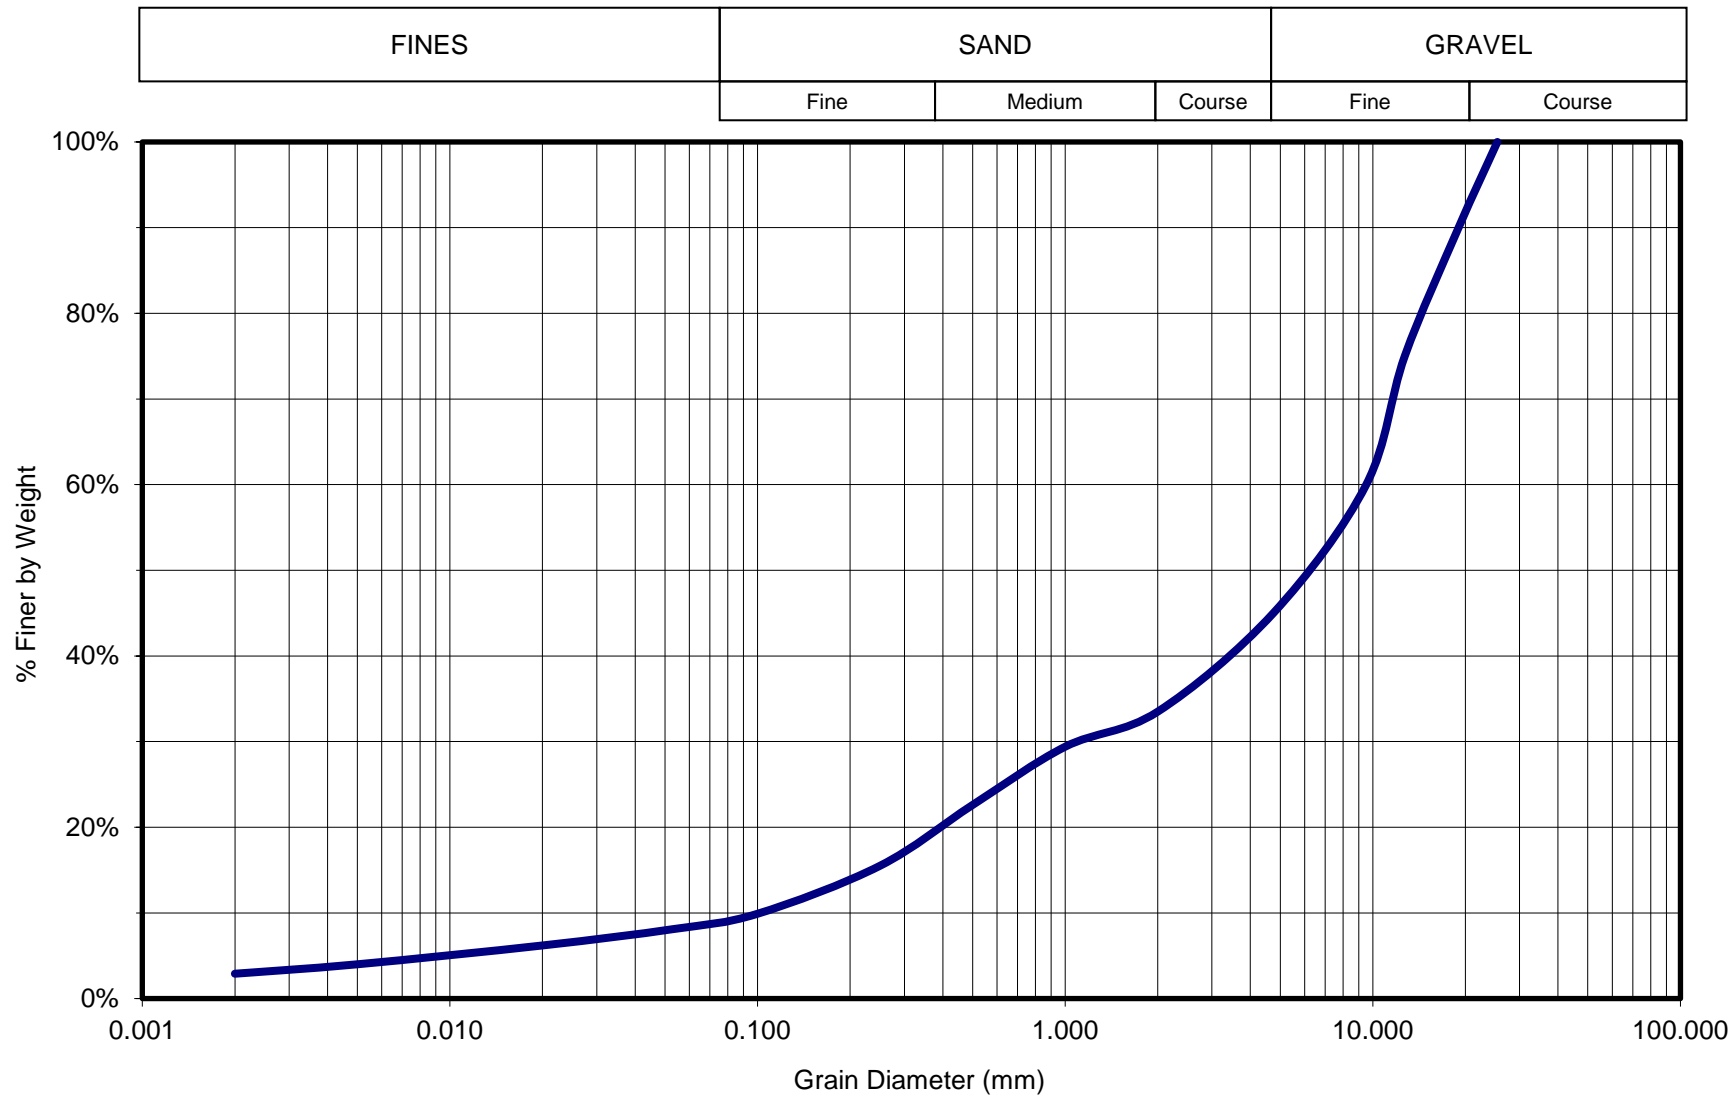
Grain size analysis for SWTP1, 11 to 12'

USDA Textural Class: gravelly coarse sandy loam

Gravel Content: (%) 66.5

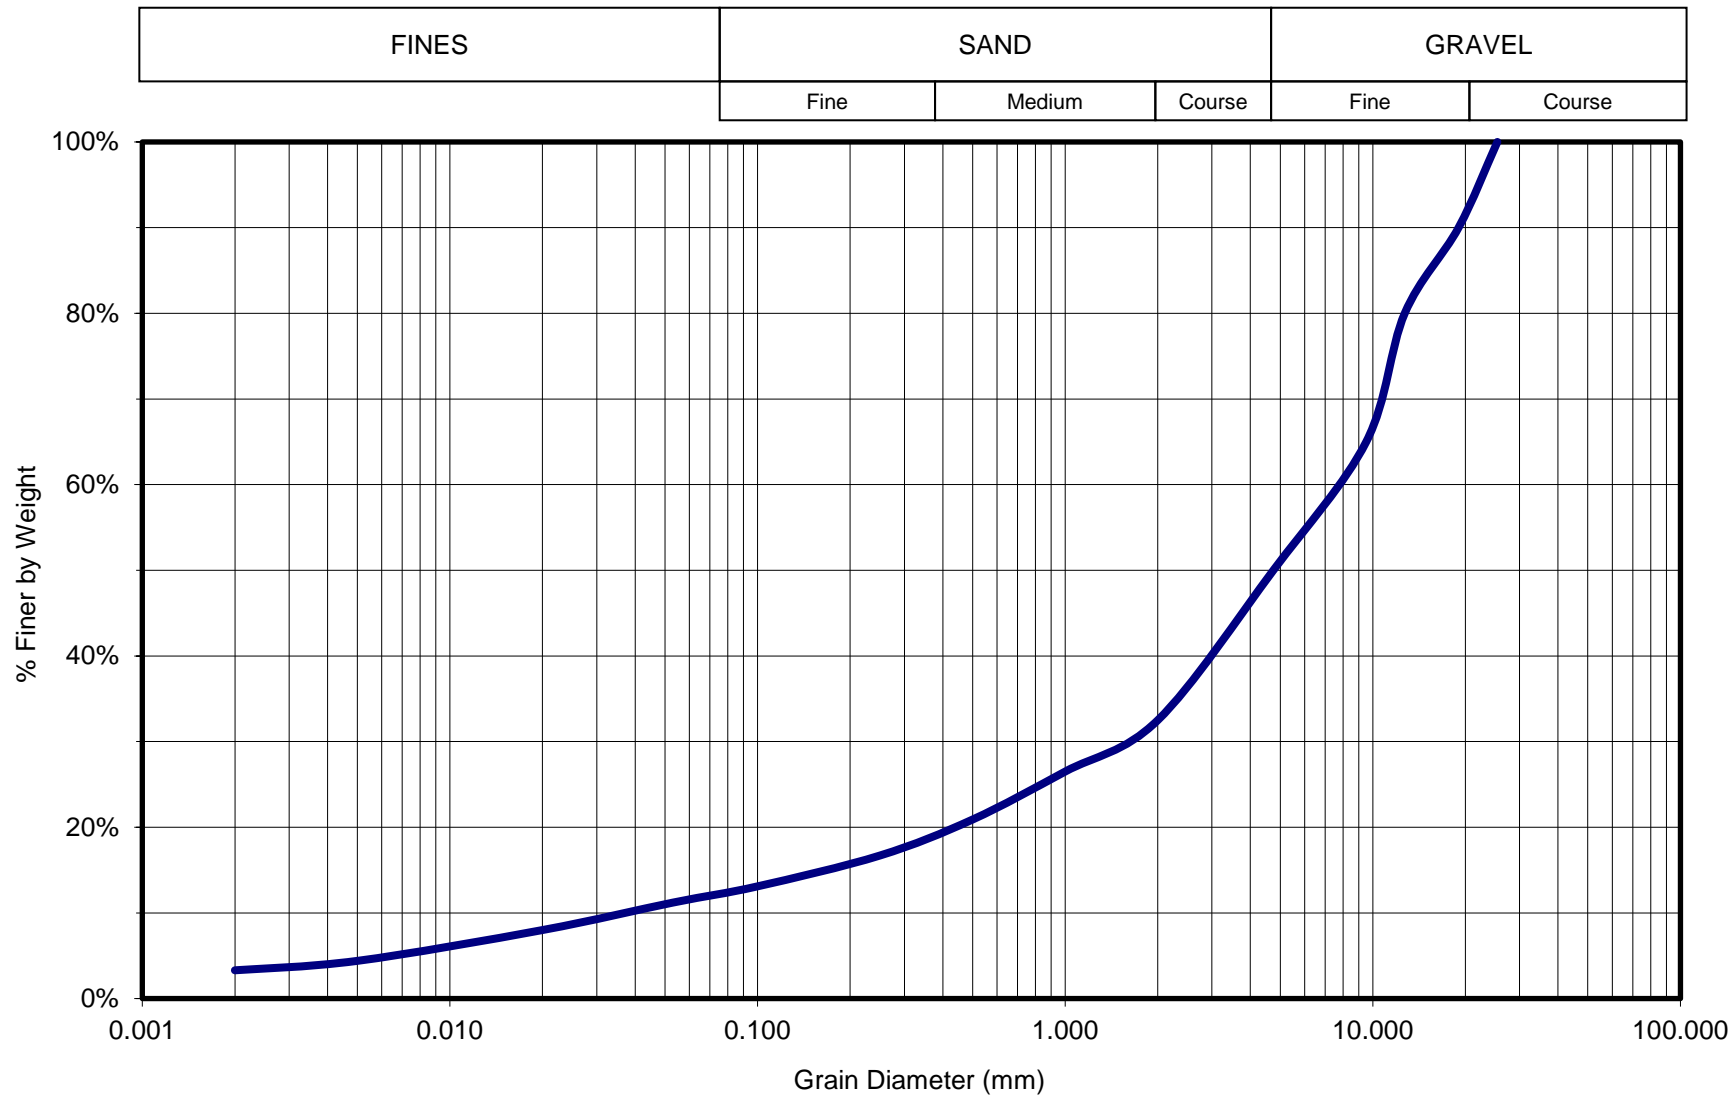
Grain size analysis for SWTP2, 10 to 12'

USDA Textural Class: gravelly coarse sandy loam

Gravel Content: (%) 67.5

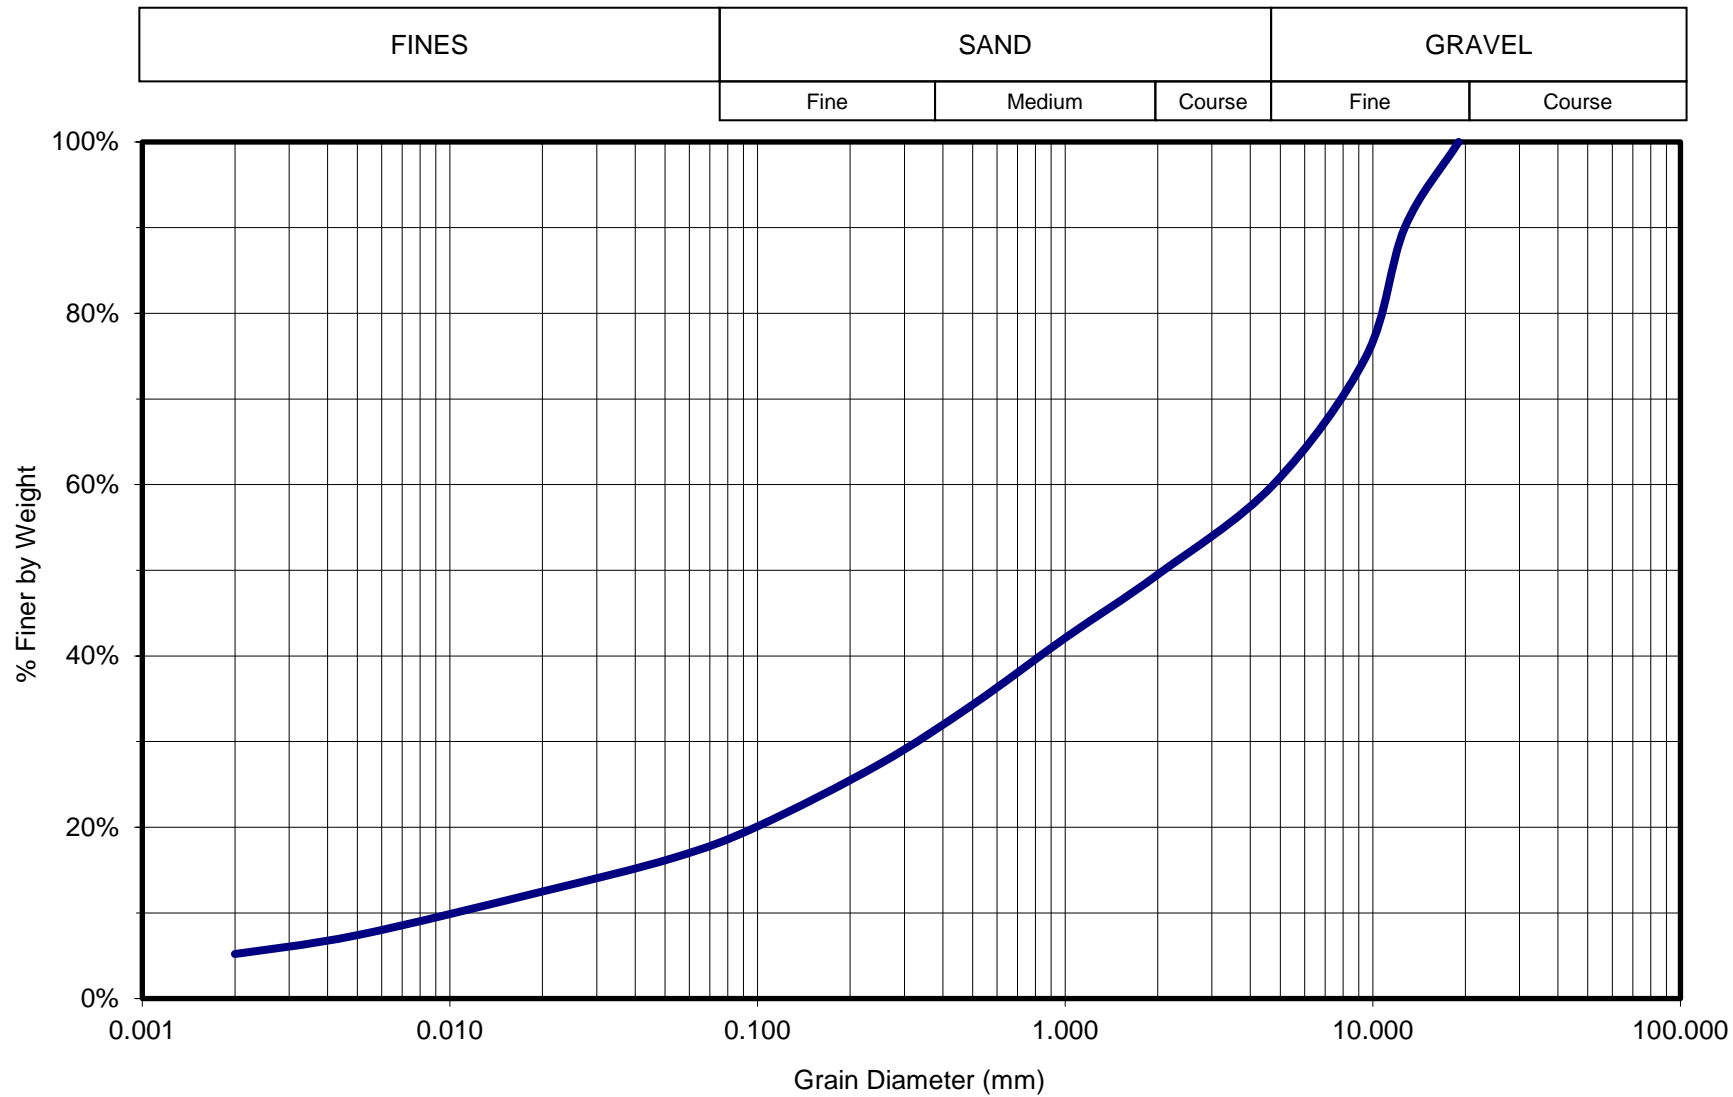
Grain size analysis for SWTP3, 5 to 6'

USDA Textural Class: gravelly coarse sandy loam

Gravel Content: (%) 50.5

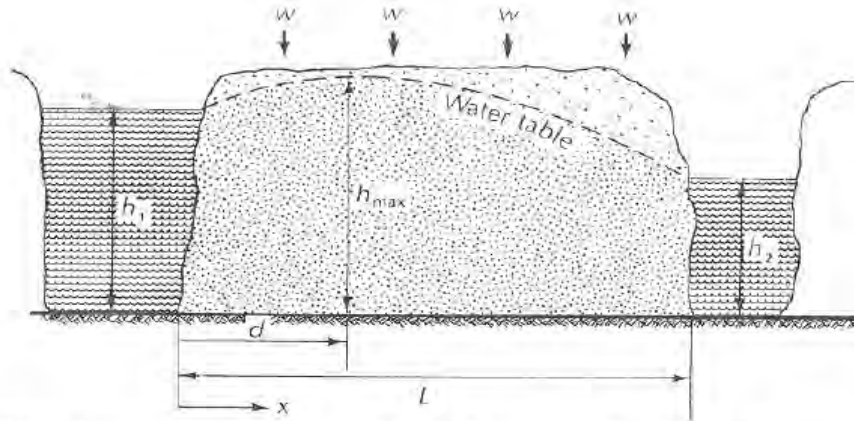
FIGURE 5.16. Unconfined flow, which is subject to infiltration or evaporation.

X-h Profile using Dupuit-Forcheimier Equation for Unconfined Flow

$$h^2 = h_1^2 - \frac{(h_1^2 - h_2^2)x}{L} + \frac{w}{K} (L - x)x$$

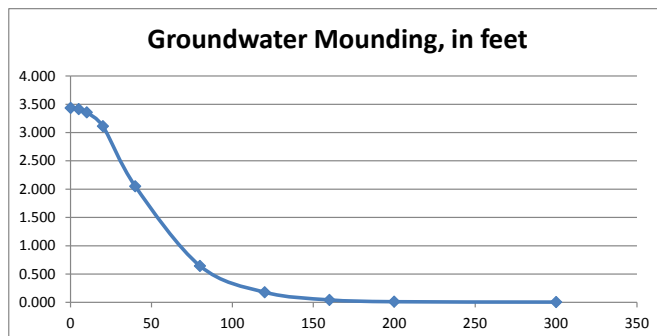
This spreadsheet solving the Hantush (1967) equation for ground-water mounding beneath an infiltration basin is made available to the general public as a convenience for those wishing to replicate values documented in the USGS Scientific Investigations Report 2010-5102 "Groundwater mounding beneath hypothetical stormwater infiltration basins" or to calculate values based on user-specified site conditions. Any changes made to the spreadsheet (other than values identified as user-specified) after transmission from the USGS could have unintended, undesirable consequences. These consequences could include, but may not be limited to: erroneous output, numerical instabilities, and violations of underlying assumptions that are inherent in results presented in the accompanying USGS published report. The USGS assumes no responsibility for the consequences of any changes made to the spreadsheet. If changes are made to the spreadsheet, the user is responsible for documenting the changes and justifying the results and conclusions.

The Hantush (1967) equation for simulating groundwater mounding beneath an infiltration basin was utilized within the mounding estimates presented in the following sections. The spreadsheet provided by USGS SIR 2010-5102 (Carleton, 2010) was used for the calculations, and a sample spreadsheet output is provided within **Attachment C**. The Hantush model assumes a uniform application rate from the subject infiltration basin to the groundwater table. Horizontal groundwater flow within an unconfined aquifer, similar to the assumptions within the DF equation, is also assumed within the Hantush formula. A transmissivity of 180 feet²/day and a specific yield of 0.30 were assumed within each mounding calculation. The flow rates, duration and basin size was varied based on the design input provided by Eaglebrook for the SDS units and Allen & Major for the stormwater infiltration units.
