# JOEGREEN ROADMAP TO ENERGY EFFICIENCY™

Audit Date: May 26<sup>th</sup>, 2010

Town of Topsfield Town Hall,

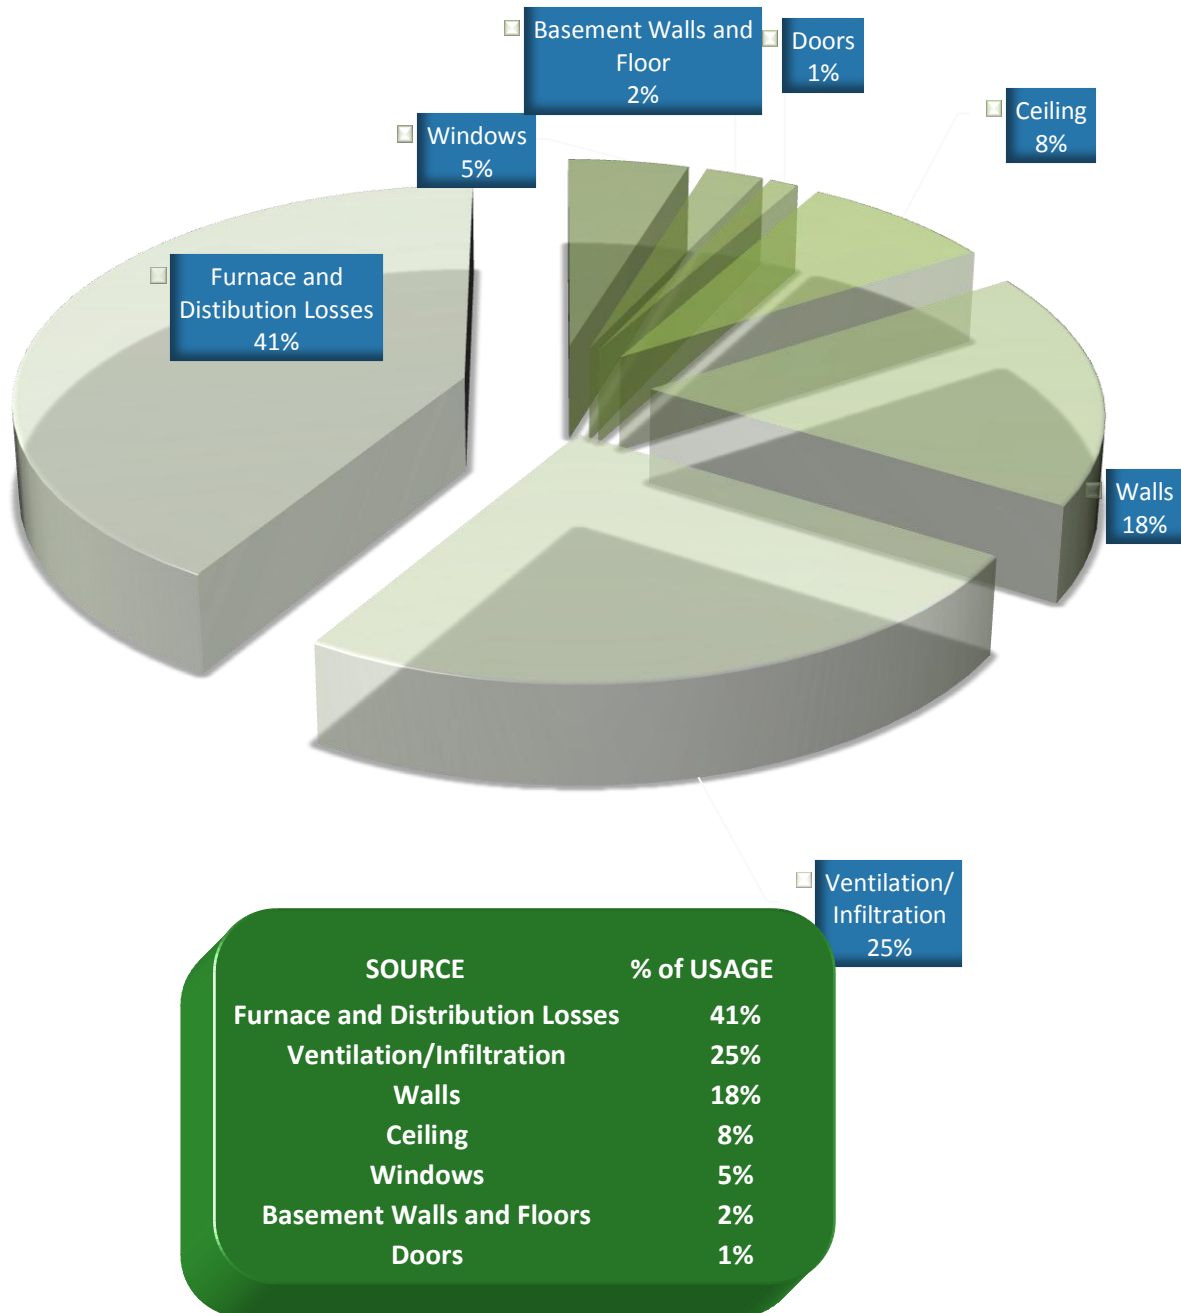
## CONDITIONED AIR LOSS

- Lack of Insulation In Walls
- Attic Edge Unsealed
- Soffits Along The Attic Edge Lack Ventilation
- Attic Lacks Sufficient Insulation
- Basement Rim Joist Unsealed
- Air Chutes Unsealed
- Air Leakage/ Infiltration through Single Pane Window Units
- Air Lock Needed Between Inside and Outside Doors
