TOPSFIELD TOWN HALL

Past, Present and Future

PAST REPAIRS AND THEIR PRESENT CONDITION

PRESENT CONDITIONS

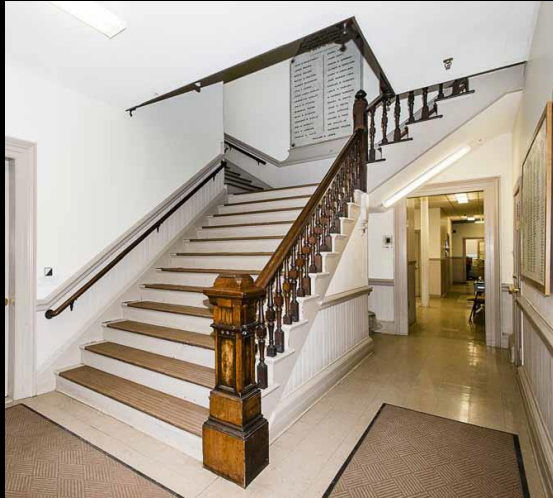
Front stair hall and second floor landing. The stair and wainscot woodwork are original. The stairs lead to the auditorium on the second floor.

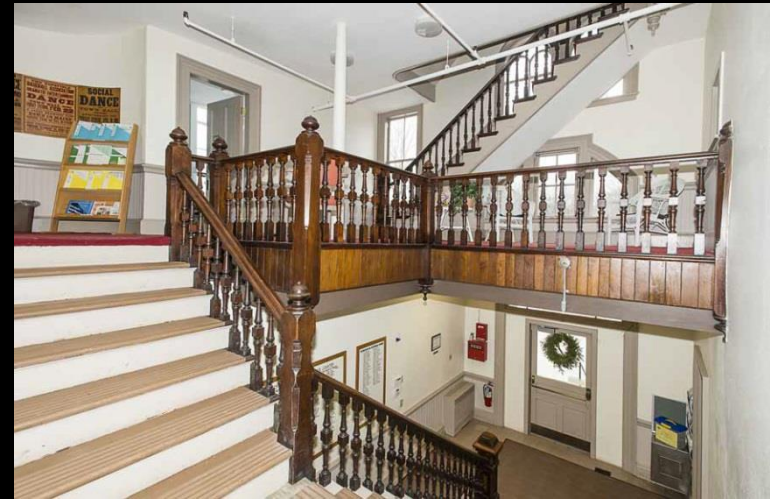
Second floor landing of the front stair. The stair in the background leads to the mezzanine of the meeting hall. The door on the extreme right is original and leads into the meeting hall. One of the main support pillars for the building rises in this area.

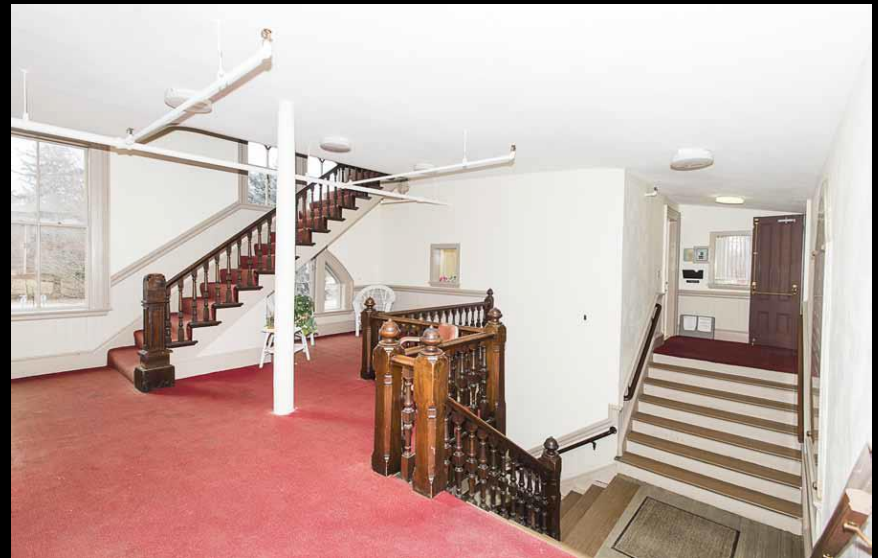
HALLWAYS AND STAIRWAYS

The plaster walls in hallways and stairways have not been painted or otherwise repaired for many years. They show cracks from long past structural movements of the building, stains from leaks, and superficial efforts to address such problems.
