Town Building Assessment Study and Capital Master Plan

Town of Topsfield, Massachusetts

February 2013

TOWN BUILDING ASSESSMENT STUDY AND CAPITAL MASTER PLAN

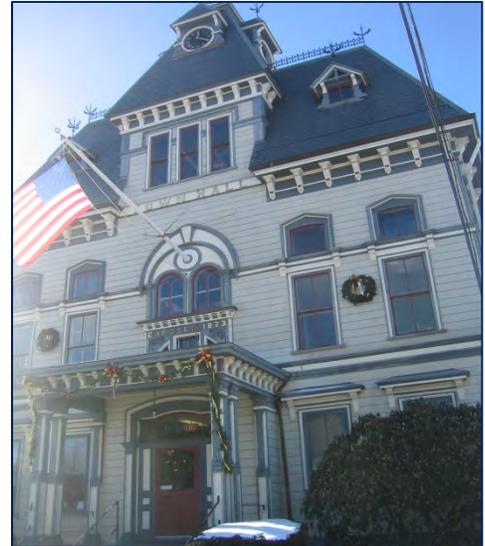
The Town Hall is a three-story (plus Basement), wood and steel framed building with interior steel pipe columns and perimeter, wood framed bearing walls. The building is rectangular in plan, with a combination hip/ mansard roof. A centrally located Clock Tower was constructed on the front (east) side of the building; there are clocks on all four sides of the tower. Covered entryways (and a handicap ramp) are located on the north (parking) side of the building. The Basement level is unfinished and is used for Storage, Archive and Mechanical Room spaces. Town offices are located at the First Floor. The original Auditorium/Stage is located at the Second Floor, along with several support spaces. The stage wall appears to have been constructed after at a later time. The Third floor consists of the upper Auditorium space, the Balcony and several additional support spaces. Access to the Clock Tower is from this level. It is proposed to restore the Second Floor to the original Auditorium use (currently open offices); access to the Balcony would be prohibited. The site is relatively level; the First Floor of the facility is approximately 4 feet above the average exterior grade. The Town Hall was constructed in the 1873; no original construction drawings were available. The building is fully sprinklered.

As observed from the Basement, it appears that there are three (3) interior, east-west column lines supporting the floors of the building (column locations vary). Typical (First Floor) support beams are 8 x 12 and typical First Floor joists are 2x10 (nominal) @ 16" o.c. Second and Third Floor construction appears to be wood framed; however, the details of this framing are unknown. Roof construction is wood framed, with heavy timber trusses clear spanning the Auditorium space in the north-south direction, supporting rafters and purlins. Foundation walls are rubble stone construction, changing to solid brick masonry at the level of the exterior grade. The Basement floor is a concrete slab on grade (thickness unknown). Supports in the Basement are typically steel pipe columns or 16" square brick piers.
