JOEGREEN ROADMAP TO ENERGY EFFICIENCY™

Audit Date: June 22nd, 2010

Town of Topsfield Library

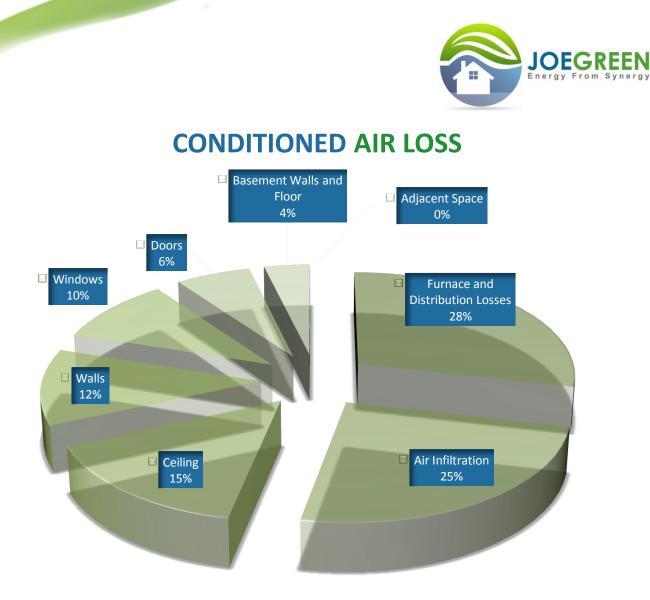
| SOURCE | % of (| USAGE | |
| Furnace and Distribution Los | ses | 29% | |
| Air Infiltration | | 25% | |
