FACILITY CONDITION ASSESSMENT

TOWN OF TOPSFIELD
8 West Common Street
Topsfield, Massachusetts 01983

137641.19R000-001.322

September 10, 2019

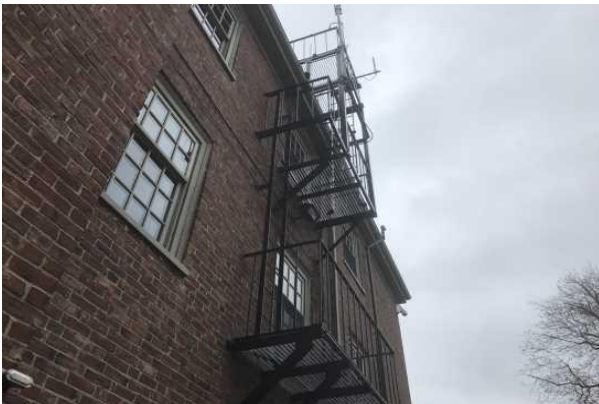
#5

REFURBISHED FIRE ESCAPE

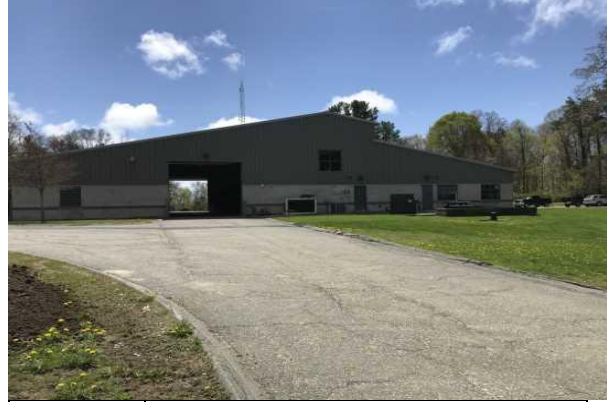
#1

FRONT ELEVATION

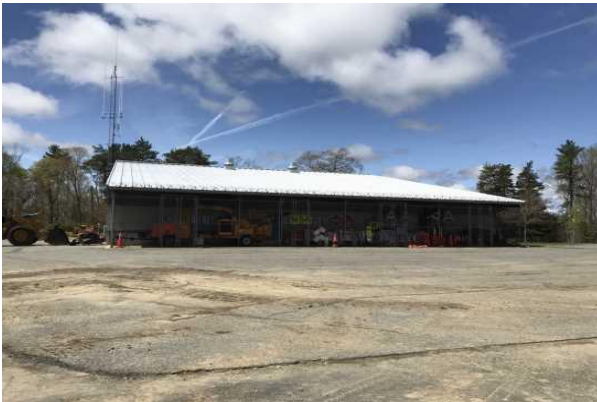
#2

LEFT ELEVATION

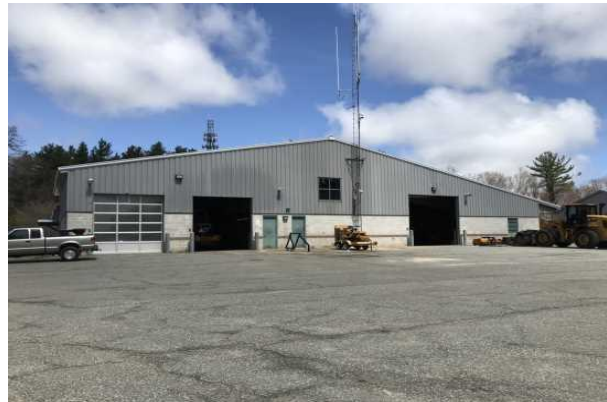
#3

REAR ELEVATION

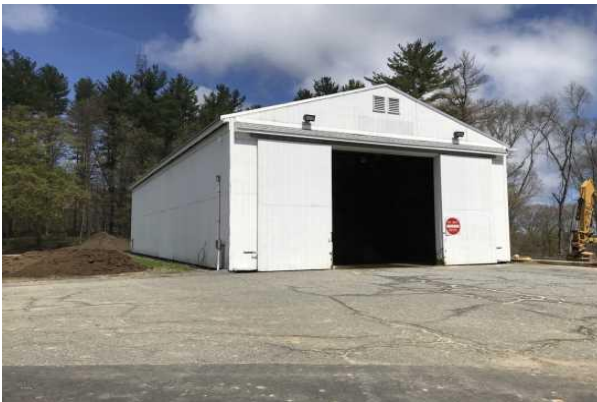
#4

RIGHT ELEVATION

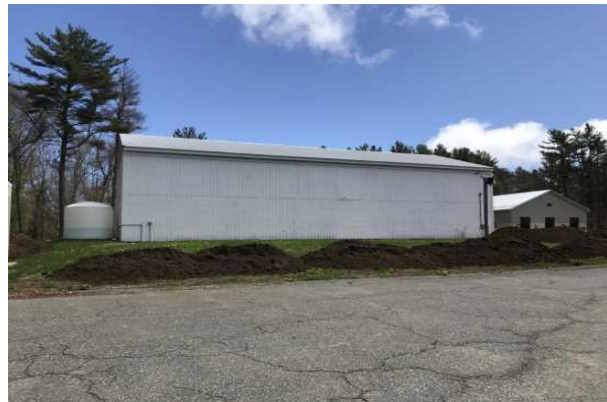
#5

SAND STORAGE SHED FRONT
ELEVATION

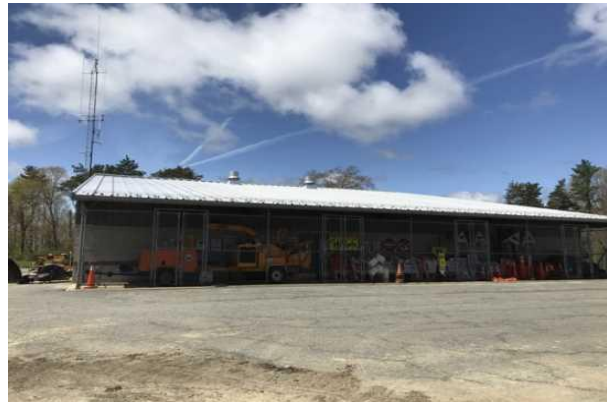
#9

STRUCTURE

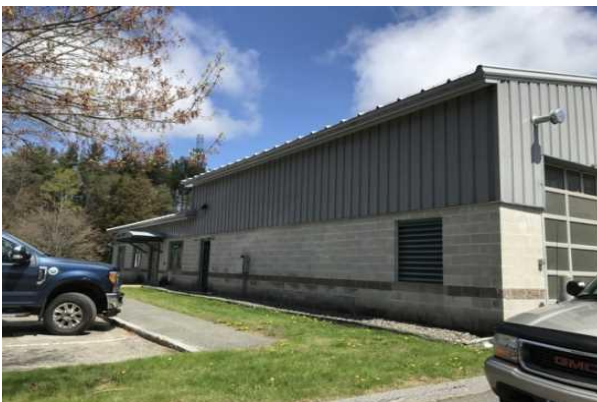
#10

METAL ROOF

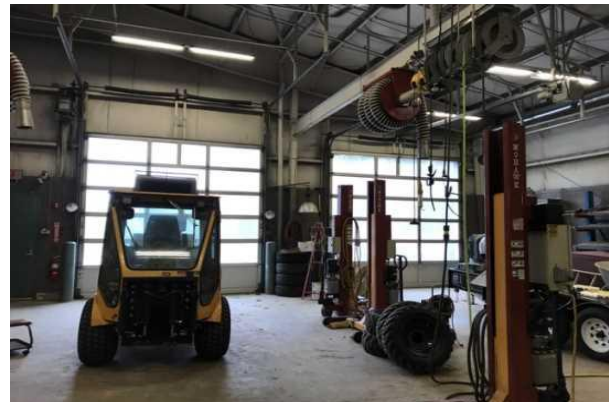
#17

GARAGE

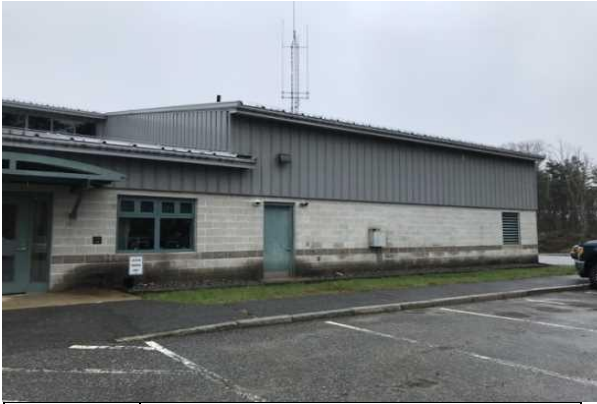
#18

GARAGE

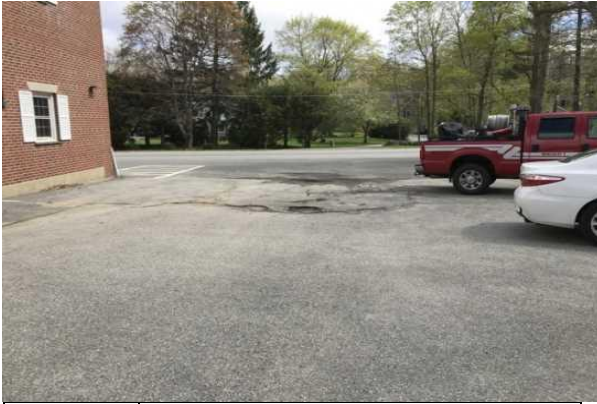
#6

FLATWORK

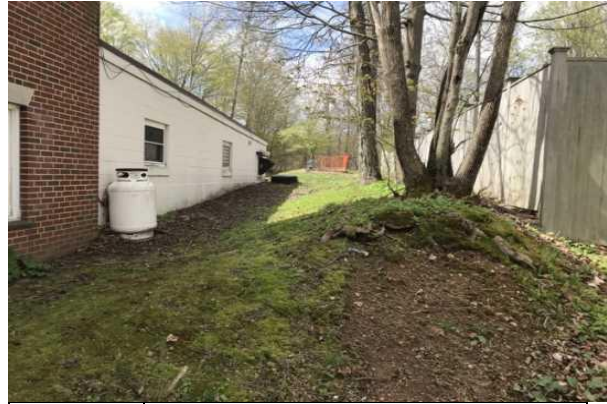
#7

FLATWORK

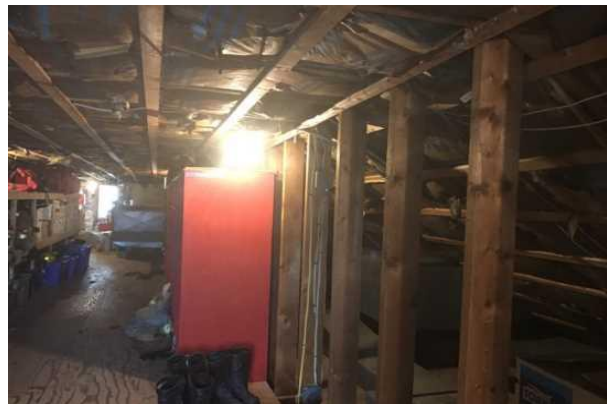
#9

STRUCTURE

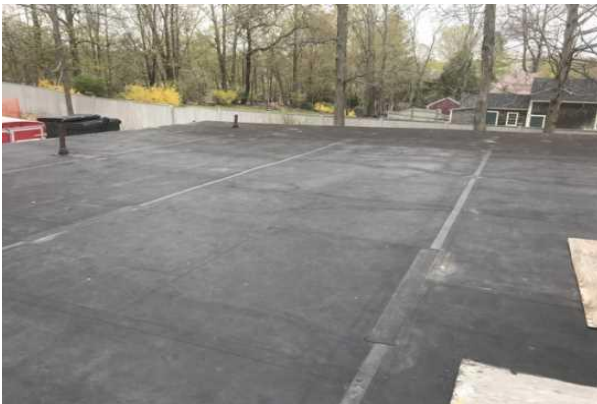
#10

STRUCTURE

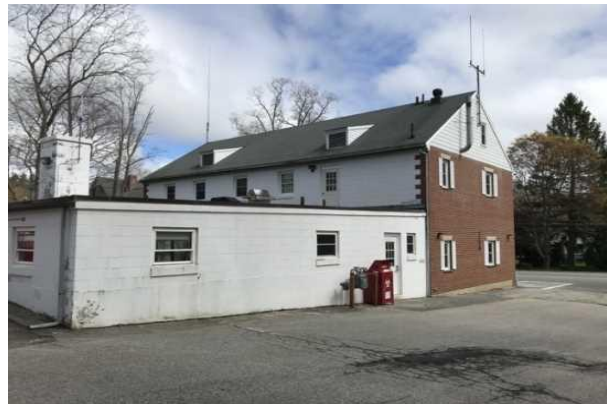
#11

FLAT ROOF

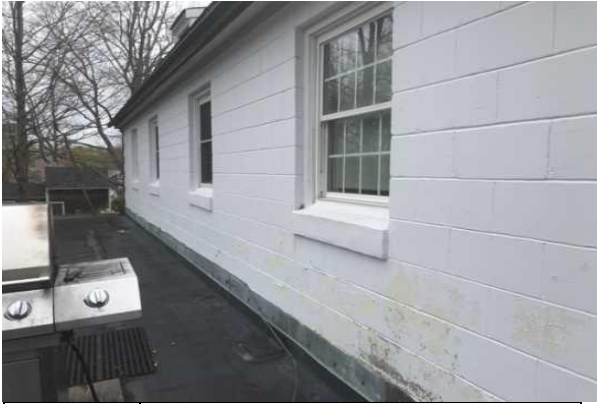
#12

PAINTED CMU WALLS

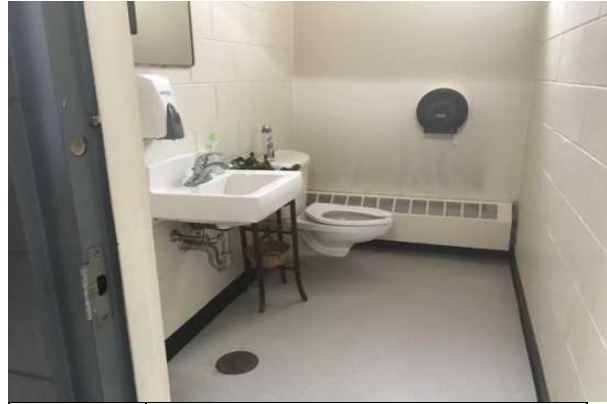
#13

PAINTED CMU

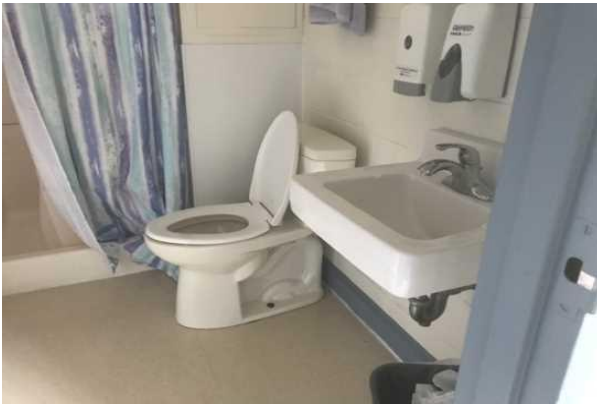
#14

RESTROOM

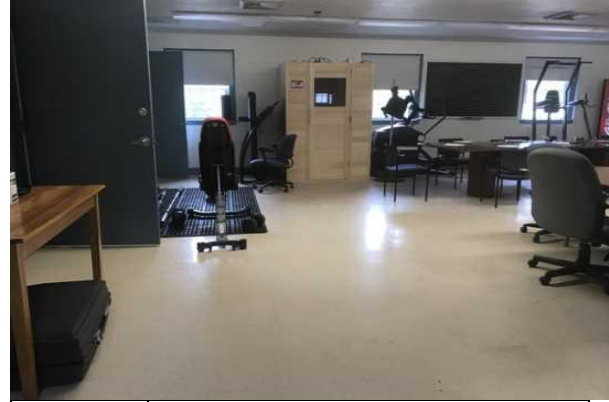
#19	TRAINING ROOM
-----	---------------

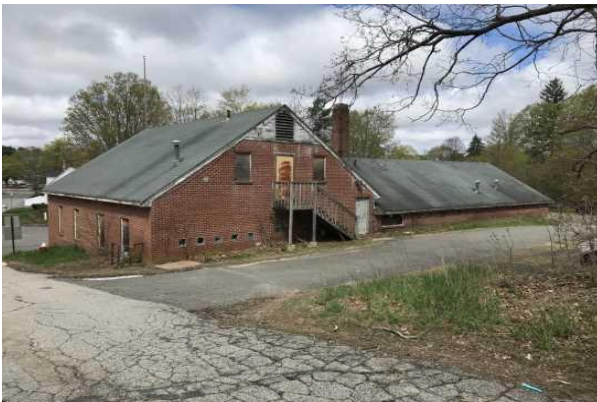
#4	RIGHT ELEVATION
----	-----------------

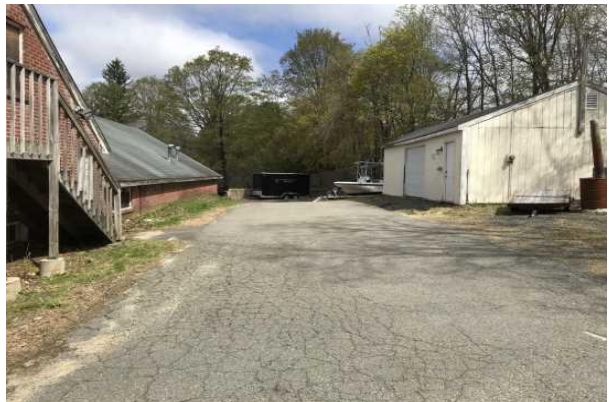
#5	REAR ELEVATION
----	----------------

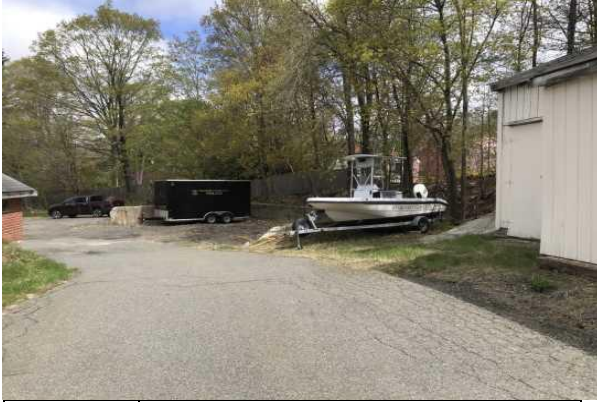
#6	ROADWAY
----	---------

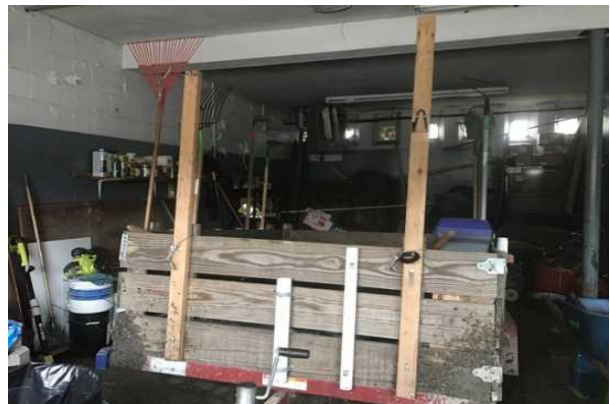
#15	BOAT STORAGE
-----	--------------

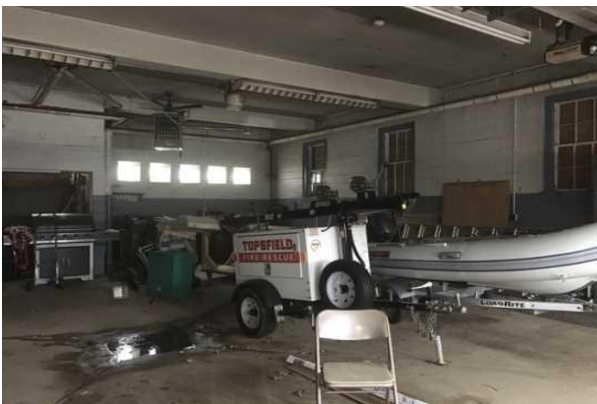
#16	EQUIPMENT STORAGE
-----	-------------------

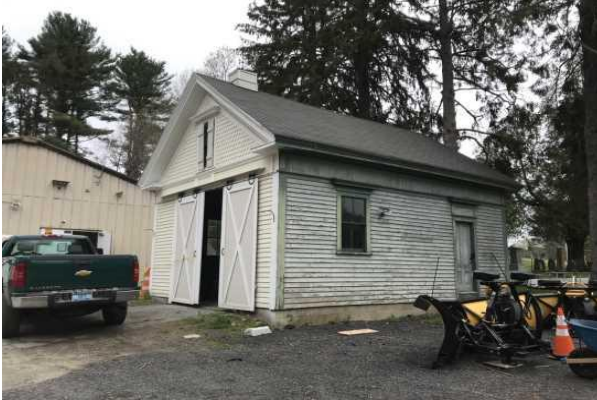
#18	STORAGE SHED
-----	--------------

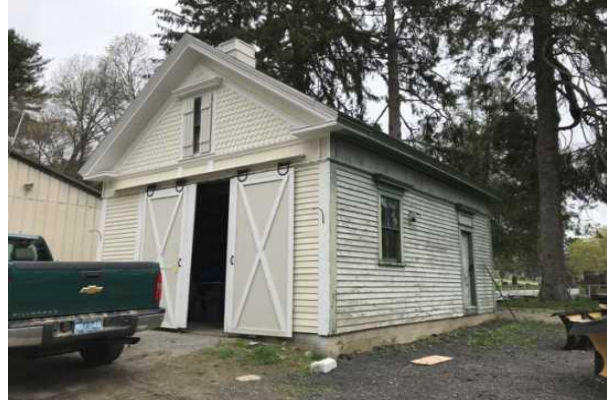
#1

ORIGINAL HURST BARN UNDER RENOVATION

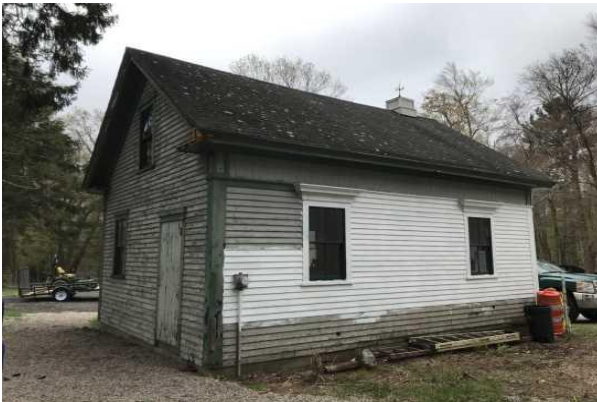
#2

NEW PAINT AT FRONT ELEVATION

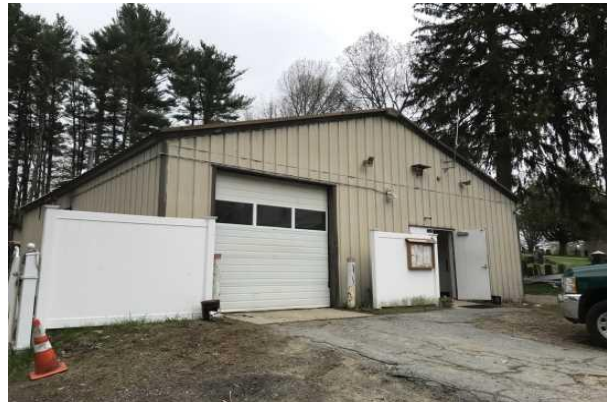
#3

BARN - REAR ELEVATION

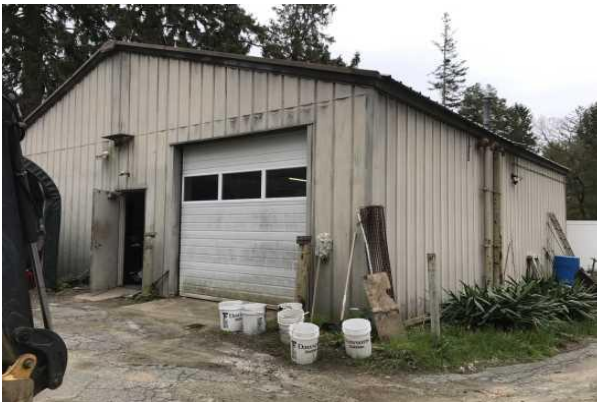
#4

FRONT ELEVATION OF PARKS AND CEMETERY BUILDING

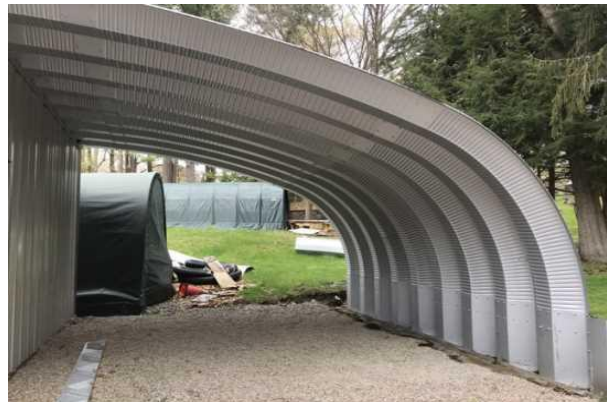
#5

REAR ELEVATION - PARKS AND CEMETERY BUILDING

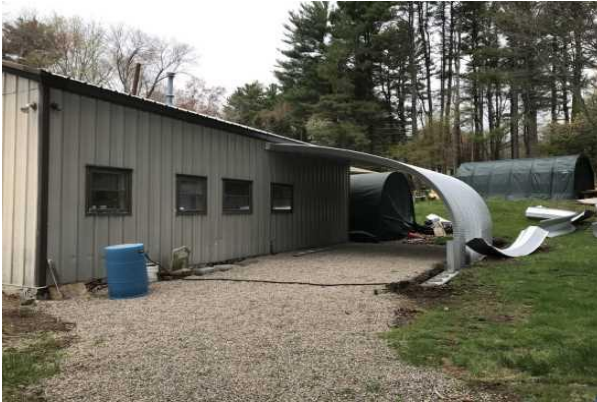
#6

STRUCTURE

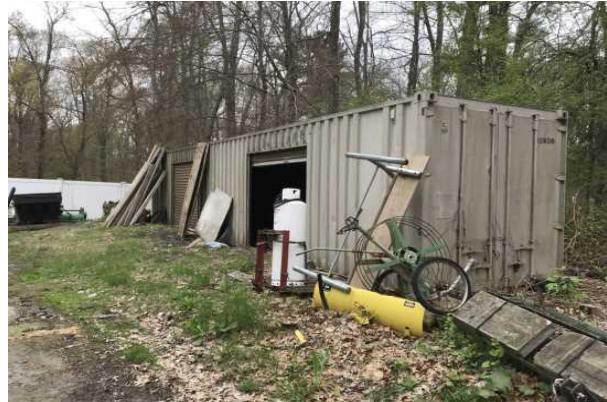
#7

RIGHT ELEVATION NEW
CONSTRUCTION FOR
EQUIPMENT STORAGE

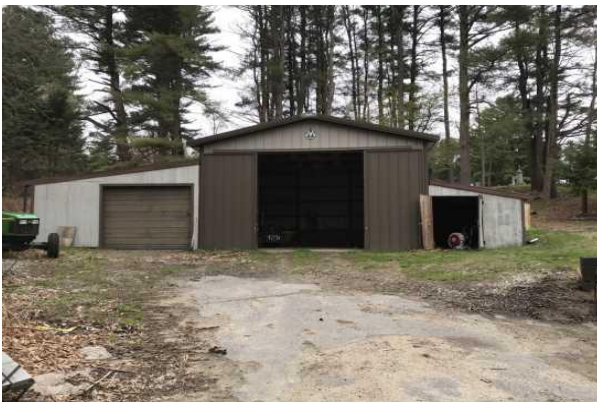
#8

STORAGE SHED

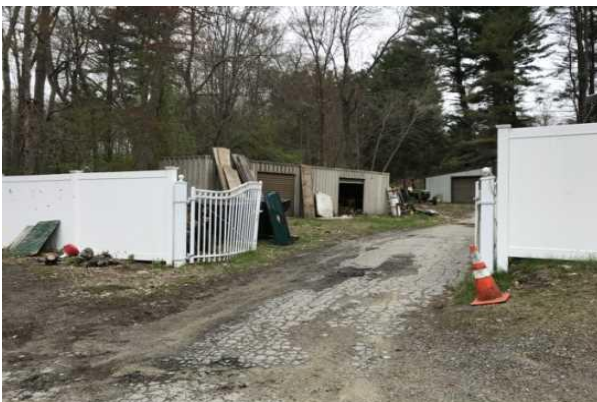
#10

ROADWAY

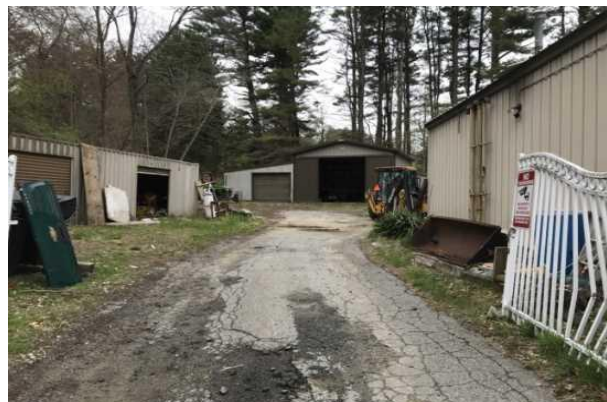
#11

ENTRANCE TO REAR STORAGE
YARD

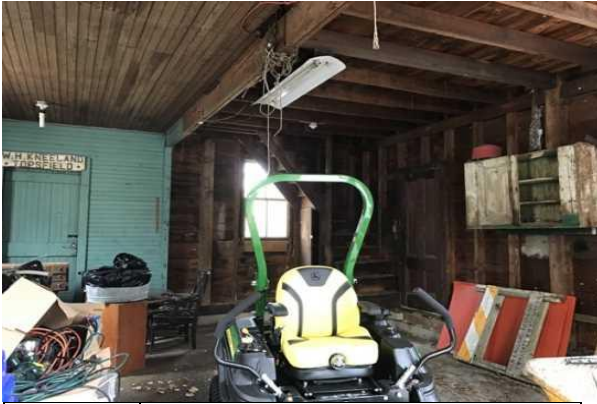
#12

STORAGE YARD

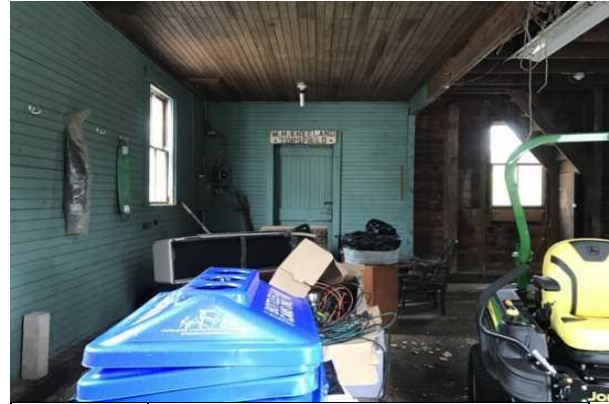
#13

WALLS

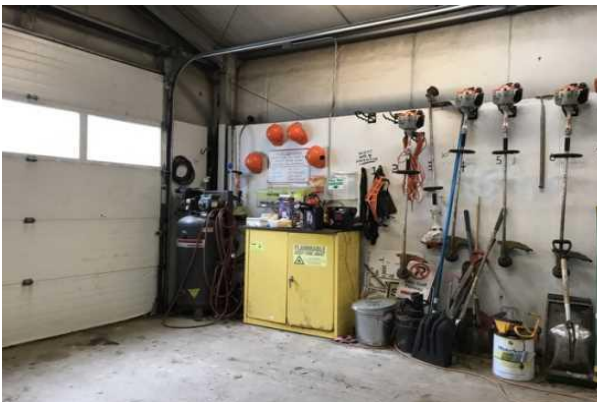
#14

BARN INTERIOR

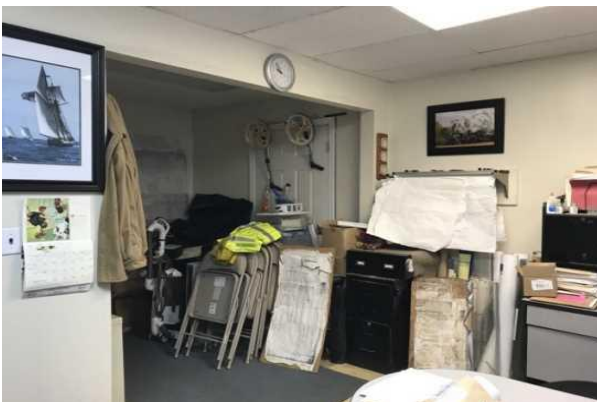
#16

ENTRANCE HALLWAY

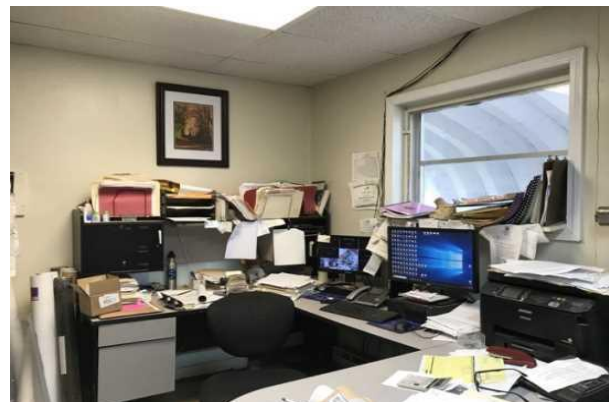
#17

OFFICE

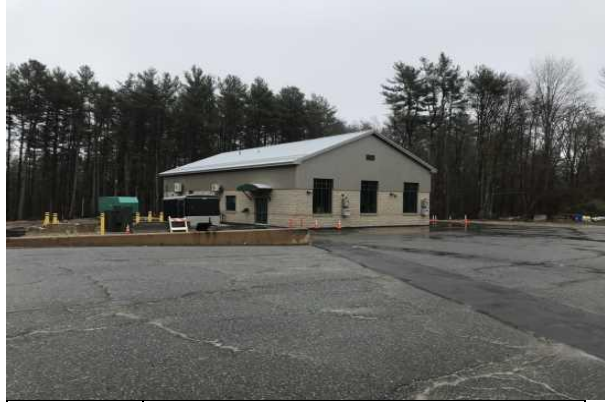
#1	FRONT ELEVATION
----	-----------------

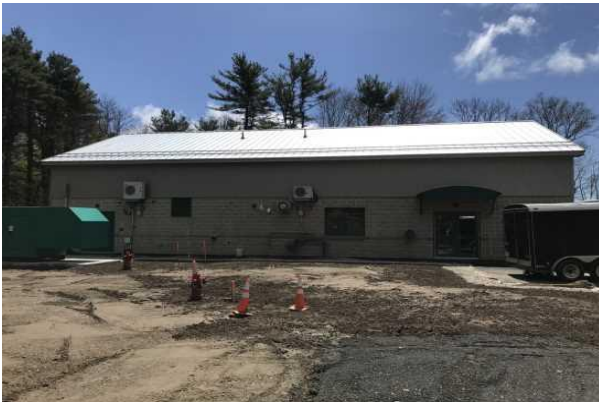
#2	RIGHT ELEVATION
----	-----------------

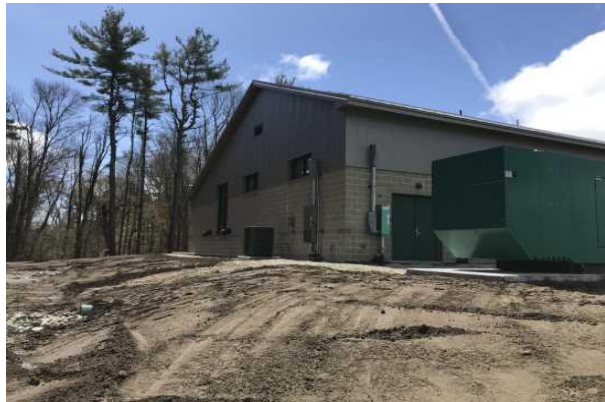
#3	LEFT ELEVATION
----	----------------

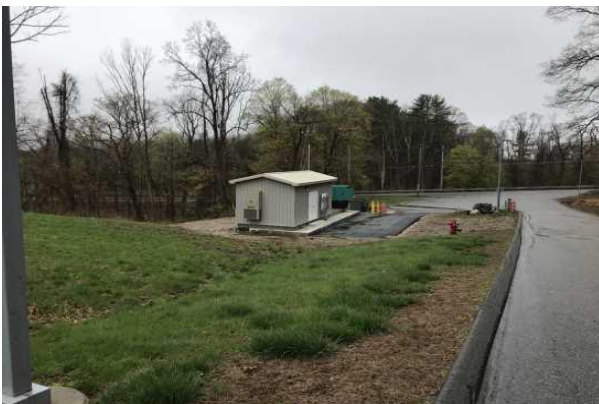
#4	REAR ELEVATION
----	----------------

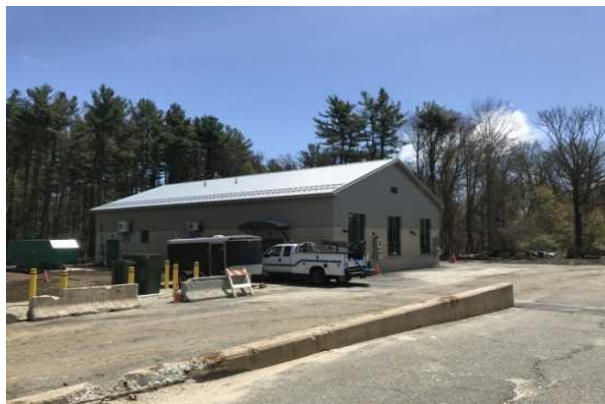
#5	PUMP HOUSE
----	------------
